Access Compliance Report Public Rights-of-Way (Curb Ramps)

Intersection ID: 21737	Main Street: HUNTINGTOWNE_FARMS_LN Cross Street: PARK_RD							Location:	NE
ADA ID: 11D1F682258F					Initial Pass/Fail: Fail Overall Compliance: No				13.75
Codes/Mitigation Info/Possible Solution				Initial Pass/Fail: Fail Overall Compliance: No Severity Score: Field Measurements/Component Compliance					
		Possible Solutions:					liance Description	Data

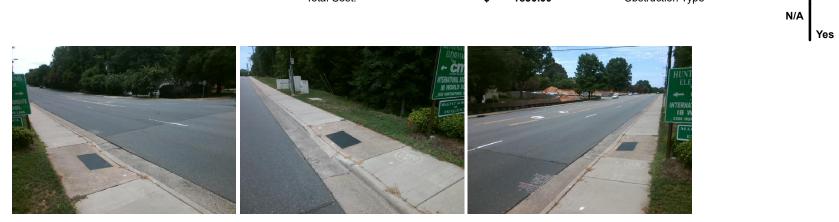
N. Company	Remove & Replace Entire Ra	amp.	N/A	Ramp Length (in)	60.0	No	Ramp Slope (%)	10.1
A A A A A A A A A A A A A A A A A A A				Yes	Ramp Width (in)	48.0	No	Ramp XSlope (%)	4.9
	いたい			N/A	Flare Type LT	N/A	N/A	Flare Type RT	N/A
	Nº An			N/A	Flare Slope LT (%)	N/A	N/A	Flare Slope RT (%)	N/A
A REAL STREET	14 72			N/A	Flare Traversable LT?	N/A	N/A	Flare Traversable RT?	N/A
	A PAR			N/A	Landing Length (in)	N/A	N/A	DWS Provided?	N/A
		Surveyor Notes:		N/A	Landing Width (in)	N/A	N/A	DWS Contrast?	N/A
	No. 10 bill	N/A		N/A	Landing Slope (%)	N/A	N/A	DWS Length (in)	N/A
				N/A	Landing X Slope (%)	N/A	N/A	DWS Full Width?	N/A

1. 1.			N/A	Landing Curb? (Y/N)	N/A	N/A	DWS Offset (in)	N/A
the states of th	ALL SALES			N/A	Shared Landing?	N/A			
	H. CAL	PROW/ADA:		N/A	Gutter Ponding?	N/A	N/A	Gutter Slope (%)	N/A
and the second s	1 10 . 40	Not Found, R304.2.2, R304.5	.3	N/A	Gutter Lip Ht (in)	N/A	N/A	Gutter X Slope (%)	N/A
				N/A	Painted X Walk1?	No	N/A	Painted X Walk2?	N/A
Provide the second seco	-	ē			X Walk 1 Direction	To W		X Walk 2 Direction	N/A
· an interest				N/A	X Walk 1 Width (in)	N/A	N/A	X Walk 2 Width (in)	N/A
Street 1 Name	PARK RD	_			X Walk 1 Slope (%)	3.1		X Walk 2 Slope (%)	N/A
Stop Condition-Street 2	None				X Walk 1 X Slope (%)	2.5		X Walk 2 X Slope (%)	N/A
Street 2 Name	N/A			N/A	Ramp inside XWalk1?	N/A	N/A	Ramp inside XWalk2?	N/A
Stop Condition-Street 1	N/A				Road Slope (%)	N/A	N/A	Clear Space?	N/A
					Road X Slope (%)	N/A	N/A	Clear Space to XWalk (in)	N/A
				N/A	Any Obstructions?	N/A	N/A	Storm Grate/Utility Hazard?	N/A
