Access Compliance Report

Public Rights-of-Way

(Curb Ramps)

| Intersection ID: 10519 | Main Street: HAMILTON_ST | Cross Street: POLK_ST | Location: SW |

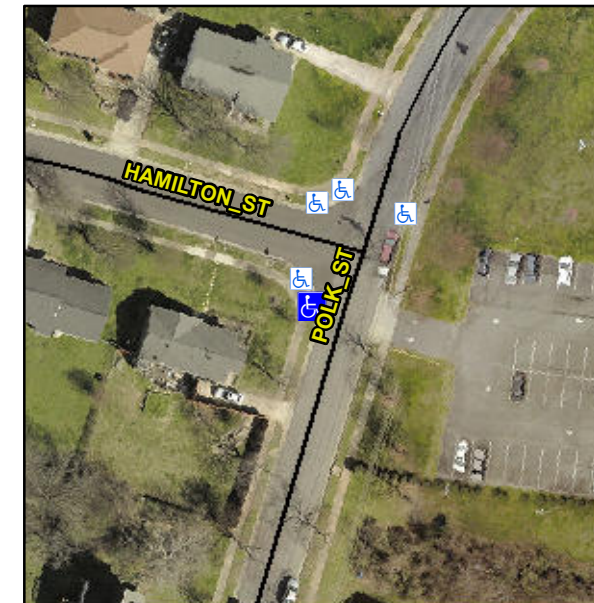
| ADA ID: 11D51F01F26A | Ramp Type: Perp | Initial Pass/Fail: Fail | Overall Compliance: No |

Not Found, R304.5.1

| Compliance | Description | Data | Compliance | Description | Data |
|---|---|---|---|---|---|
| N/A | Ramp Length (in) | 58.0 | Yes | Ramp Slope (%) | 6.4 |
| No | Ramp Width (in) | 47.0 | Yes | Ramp XSlope (%) | 1.1 |

Remove & Replace Entire Ramp.

Total Cost: \$ 1850.00
