Access Compliance Report

Public Rights-of-Way

(Curb Ramps)

Intersection ID: N/A	Main Street: BEREWICK COMMONS PKY	Cross Street: LANGWELL LN	Location: NW
ADA ID: 11DBF82749D7	Ramp Type: Perp	Initial Pass/Fail: Fail	Overall Compliance: No
Codes/Mitigation Info/Possible Solution		Field Measurements/Component Compliance

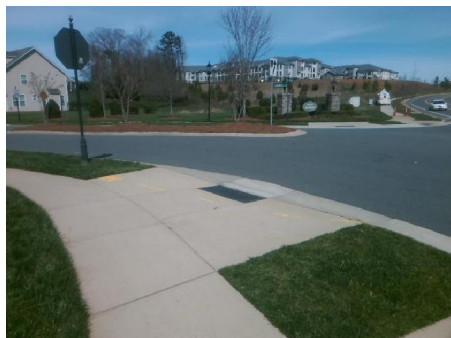
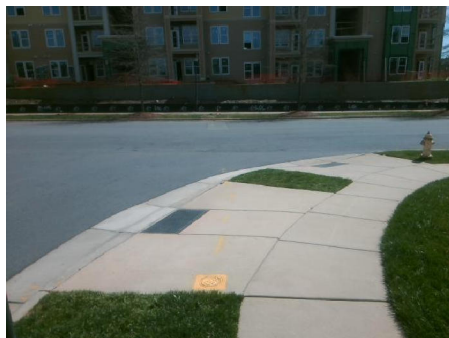
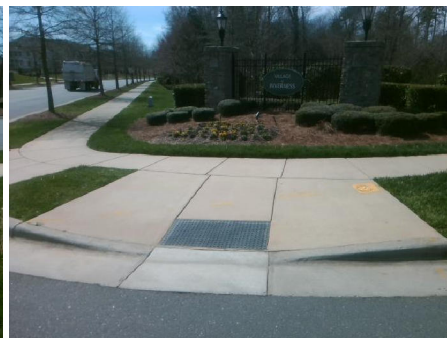
R304.2.2, R304.5.3

Compliance	Description	Data	Compliance	Description	Data
N/A	Ramp Length (in)	87.0	No	Ramp Slope (%)	8.9
Yes	Ramp Width (in)	48.0	No	Ramp XSlope (%)	4.6
N/A	Flare Type LT	N/A	N/A	Flare Type RT	N/A
N/A	Flare Slope LT (%)	N/A	N/A	Flare Slope RT (%)	N/A
N/A	Flare Traversable LT?	N/A	N/A	Flare Traversable RT?	N/A
N/A	Landing Length (in)	N/A	N/A	DWS Provided?	N/A
N/A	Landing Width (in)	N/A	N/A	DWS Contrast?	N/A
N/A	Landing Slope (%)	N/A	N/A	DWS Length (in)	N/A
N/A	Landing X Slope (%)	N/A	N/A	DWS Full Width?	N/A
N/A	Landing Curb? (Y/N)	N/A	N/A	DWS Offset (in)	N/A
N/A	Shared Landing?	N/A			
N/A	Gutter Ponding?	N/A	N/A	Gutter Slope (%)	N/A
N/A	Gutter Lip Ht (in)	N/A	N/A	Gutter X Slope (%)	N/A
N/A	Painted X Walk1?	No	N/A	Painted X Walk2?	N/A
	X Walk 1 Direction	To NE		X Walk 2 Direction	N/A
N/A	X Walk 1 Width (in)	N/A	N/A	X Walk 2 Width (in)	N/A
	X Walk 1 Slope (%)	1.4		X Walk 2 Slope (%)	N/A
	X Walk 1 X Slope (%)	4.3		X Walk 2 X Slope (%)	N/A

N/A	Ramp inside XWalk1?	N/A	N/A	Ramp inside XWalk2?	N/A
	Road Slope (%)	N/A	N/A	Clear Space?	N/A
	Road X Slope (%)	N/A	N/A	Clear Space to XWalk (in)	N/A
N/A	Any Obstructions?	N/A	N/A	Storm Grate/Utility Hazard?	N/A
	Obstruction Type			Storm Grate/Utility Type	
		N/A			N/A
			Yes	Surface Condition? (G/P)	Good

Remove & Replace Entire Ramp.

\$ 1850.00
