Access Compliance Report

Public Rights-of-Way

(Curb Ramps)

Intersection ID: 12412	Main Street: BELMONT_AV	Cross Street: PEGRAM_ST	Location: E
ADA ID: 11FBB195AC37	Ramp Type: BlendTrans1	Initial Pass/Fail: Fail	Overall Compliance: No
		Severity Score: 8.75

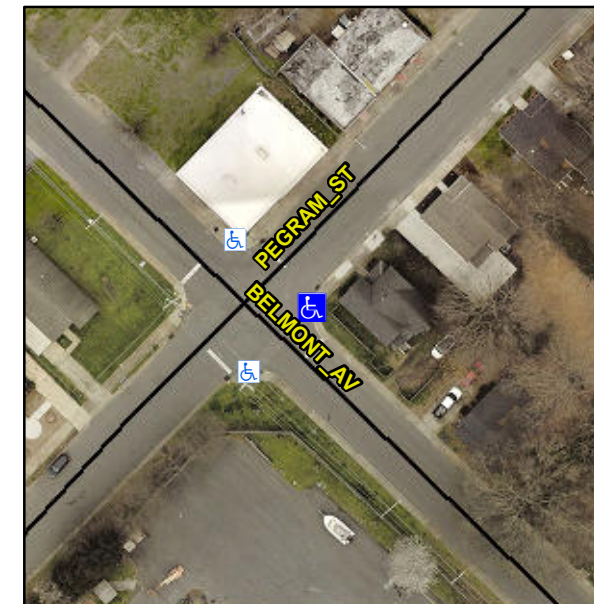
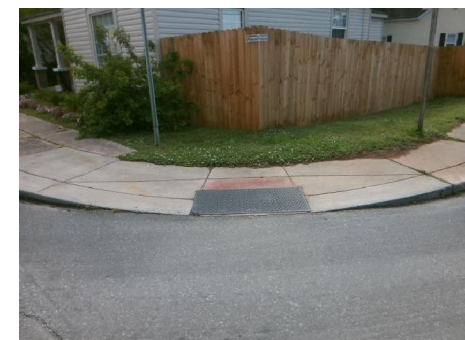
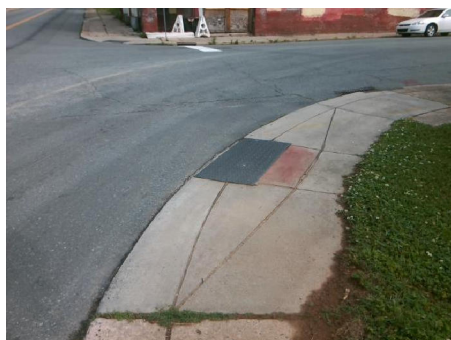
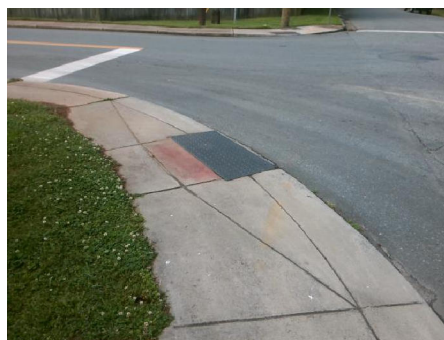
Compliance	Description	Data	Compliance	Description	Data
N/A	Ramp Length (in)	25.0	Yes	BlendTrans Slope (%)	4.4
No	Ramp Width (in)	40.5	Yes	BlendTrans XSlope (%)	1.0
N/A	Flare Type LT	N/A	N/A	Flare Type RT	N/A
N/A	Flare Slope LT (%)	N/A	N/A	Flare Slope RT (%)	N/A
N/A	Flare Traversable LT?	N/A	N/A	Flare Traversable RT?	N/A
N/A	Landing Length (in)	N/A	N/A	DWS Provided?	N/A
N/A	Landing Width (in)	N/A	N/A	DWS Contrast?	N/A
N/A	Landing Slope (%)	N/A	N/A	DWS Length (in)	N/A
N/A	Landing X Slope (%)	N/A	N/A	DWS Full Width?	N/A
N/A	Landing Curb? (Y/N)	N/A	N/A	DWS Offset (in)	N/A
N/A	Shared Landing?	N/A			
N/A	Gutter Ponding?	N/A	N/A	Gutter Slope (%)	N/A
N/A	Gutter Lip Ht (in)	N/A	N/A	Gutter X Slope (%)	N/A
N/A	Painted X Walk1?	No	N/A	Painted X Walk2?	No
	X Walk 1 Direction	To NW		X Walk 2 Direction	To SW
	X Walk 1 Width (in)	N/A		X Walk 2 Width (in)	N/A
	X Walk 1 Slope (%)	2.9		X Walk 2 Slope (%)	1.4
	X Walk 1 X Slope (%)	0.7		X Walk 2 X Slope (%)	5.0

N/A	Ramp inside XWalk1?	N/A	N/A	Ramp inside XWalk2?	N/A
	Road Slope (%)	2.1		Clear Space?	N/A
	Road X Slope (%)	4.4	N/A	Clear Space to XWalk (in)	N/A
N/A	Any Obstructions?	N/A	N/A	Storm Grate/Utility Hazard?	N/A
	Obstruction Type			Storm Grate/Utility Type	
		N/A			N/A
			Yes	Surface Condition? (G/P)	Good
			N/A	Curb Slope (%)	N/A

Remove & Replace Curb Ramp With Two New Directional Ramps or Equivalent.
