Access Compliance Report

Public Rights-of-Way

(Curb Ramps)

Intersection ID: 26384	Main Street: BEVINGTON_PL	Cross Street: ELM_LN	Location: SW
ADA ID: 11FC4DCA31AD	Ramp Type: Perp	Initial Pass/Fail: Fail	Overall Compliance: No
		Severity Score: 8.75

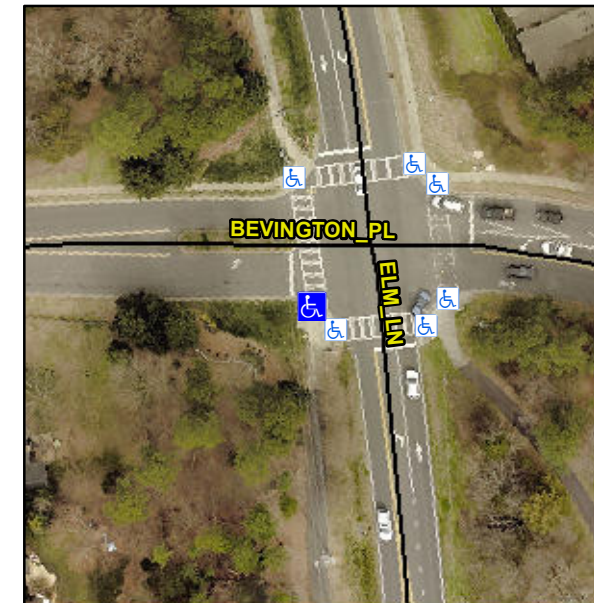
Not Found, R304.5.1

Compliance	Description	Data	Compliance	Description	Data
N/A	Ramp Length (in)	71.0	Yes	Ramp Slope (%)	5.8
No	Ramp Width (in)	47.0	Yes	Ramp XSlope (%)	1.6
N/A	Flare Type LT	N/A	N/A	Flare Type RT	N/A
N/A	Flare Slope LT (%)	N/A	N/A	Flare Slope RT (%)	N/A
N/A	Flare Traversable LT?	N/A	N/A	Flare Traversable RT?	N/A
N/A	Landing Length (in)	N/A	N/A	DWS Provided?	N/A
N/A	Landing Width (in)	N/A	N/A	DWS Contrast?	N/A
N/A	Landing Slope (%)	N/A	N/A	DWS Length (in)	N/A
N/A	Landing X Slope (%)	N/A	N/A	DWS Full Width?	N/A
N/A	Landing Curb? (Y/N)	N/A	N/A	DWS Offset (in)	N/A
N/A	Shared Landing?	N/A			
N/A	Gutter Ponding?	N/A	N/A	Gutter Slope (%)	N/A
N/A	Gutter Lip Ht (in)	N/A	N/A	Gutter X Slope (%)	N/A
N/A	Painted X Walk1?	Yes	N/A	Painted X Walk2?	N/A
	X Walk 1 Direction	To N		X Walk 2 Direction	N/A
N/A	X Walk 1 Width (in)	112.0	N/A	X Walk 2 Width (in)	N/A
	X Walk 1 Slope (%)	4.5		X Walk 2 Slope (%)	N/A
	X Walk 1 X Slope (%)	0.0		X Walk 2 X Slope (%)	N/A

N/A	Ramp inside XWalk1?	Yes	N/A	Ramp inside XWalk2?	N/A
	Road Slope (%)	N/A	N/A	Clear Space?	N/A
	Road X Slope (%)	N/A	N/A	Clear Space to XWalk (in)	N/A
N/A	Any Obstructions?	N/A	N/A	Storm Grate/Utility Hazard?	N/A
	Obstruction Type			Storm Grate/Utility Type	
		N/A			N/A
		Yes		Surface Condition? (G/P)	Good

Remove & Replace Entire Ramp.

Total Cost: \$ 1850.00
