Access Compliance Report

Public Rights-of-Way

(Curb Ramps)

Intersection ID: 10025796	Main Street: EDGEHILL_RD_NORTH	Cross Street: N/A	Location: SW
ADA ID: 11FD3D693E3A	Ramp Type: PerpDiag	Initial Pass/Fail: Fail	Overall Compliance: No
			Severity Score: 26.25

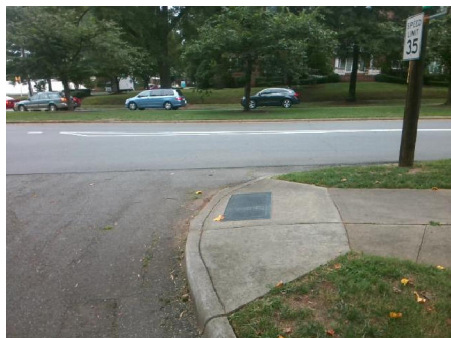
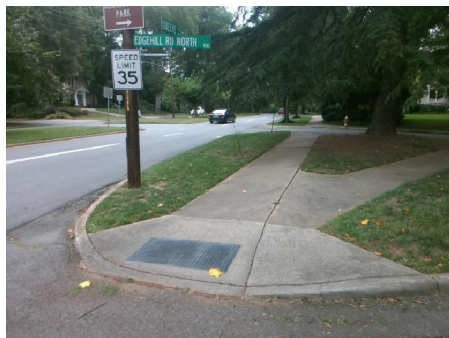
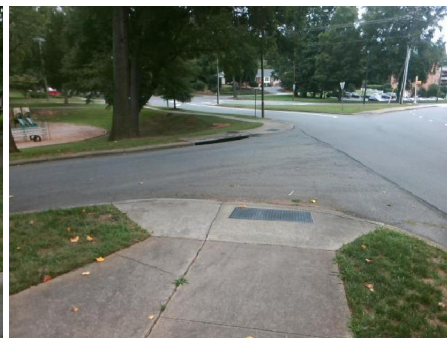
Not Found, R304.2.2, R304.5.3

Compliance	Description	Data	Compliance	Description	Data
N/A	Ramp Length (in)	67.0	No	Ramp Slope (%)	12.4
Yes	Ramp Width (in)	48.0	No	Ramp XSlope (%)	4.0
N/A	Flare Type LT	N/A	N/A	Flare Type RT	N/A
N/A	Flare Slope LT (%)	N/A	N/A	Flare Slope RT (%)	N/A
N/A	Flare Traversable LT?	N/A	N/A	Flare Traversable RT?	N/A
N/A	Landing Length (in)	N/A	N/A	DWS Provided?	N/A
N/A	Landing Width (in)	N/A	N/A	DWS Contrast?	N/A
N/A	Landing Slope (%)	N/A	N/A	DWS Length (in)	N/A
N/A	Landing X Slope (%)	N/A	N/A	DWS Full Width?	N/A
N/A	Landing Curb? (Y/N)	N/A	N/A	DWS Offset (in)	N/A
N/A	Shared Landing?	N/A			
N/A	Gutter Ponding?	N/A	N/A	Gutter Slope (%)	N/A
N/A	Gutter Lip Ht (in)	N/A	N/A	Gutter X Slope (%)	N/A
N/A	Painted X Walk1?	No	N/A	Painted X Walk2?	No
	X Walk 1 Direction	To NW		X Walk 2 Direction	To SE
N/A	X Walk 1 Width (in)	N/A	N/A	X Walk 2 Width (in)	N/A
	X Walk 1 Slope (%)	0.0		X Walk 2 Slope (%)	4.3
	X Walk 1 X Slope (%)	4.2		X Walk 2 X Slope (%)	1.0

N/A	Ramp inside XWalk1?	N/A	N/A	Ramp inside XWalk2?	N/A
	Road Slope (%)	1.3	N/A	Clear Space?	N/A
	Road X Slope (%)	4.2	N/A	Clear Space to XWalk (in)	N/A
N/A	Any Obstructions?	N/A	N/A	Storm Grate/Utility Hazard?	N/A
	Obstruction Type			Storm Grate/Utility Type	
		N/A			N/A
			Yes	Surface Condition? (G/P)	Good

Remove & Replace Curb Ramp With Two New Directional Ramps or Equivalent.
