# Access Compliance Report

## Public Rights-of-Way

### (Curb Ramps)

Intersection ID: 12358	Main Street: HARRILL_ST	Cross Street: VAN_EVERY_ST	Location:	N
ADA ID: 11FEF7D0960B	Ramp Type: Perp	Initial Pass/Fail: Fail	Overall Compliance: No	Severity Score: 36.25
Codes/Mitigation Info/Possible Solution		Field Measurements/Component Compliance

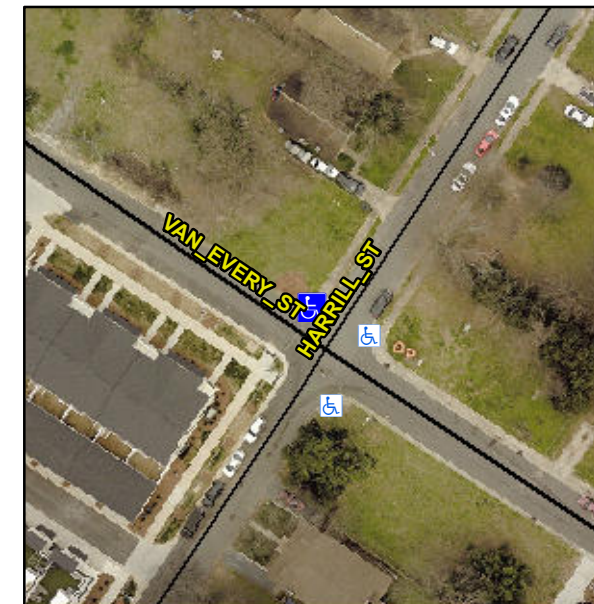
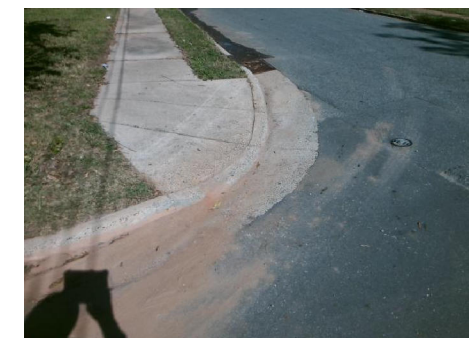
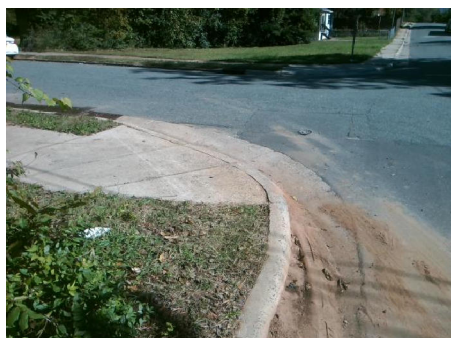
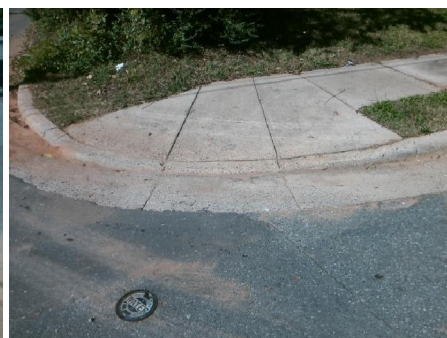
**Not Found, R304.5.1, R304.5.3**

Compliance	Description	Data	Compliance	Description	Data
N/A	Ramp Length (in)	78.0	Yes	Ramp Slope (%)	6.3
No	Ramp Width (in)	31.0	No	Ramp XSlope (%)	2.3
N/A	Flare Type LT	N/A	N/A	Flare Type RT	N/A
N/A	Flare Slope LT (%)	N/A	N/A	Flare Slope RT (%)	N/A
N/A	Flare Traversable LT?	N/A	N/A	Flare Traversable RT?	N/A
N/A	Landing Length (in)	N/A	N/A	DWS Provided?	N/A
N/A	Landing Width (in)	N/A	N/A	DWS Contrast?	N/A
N/A	Landing Slope (%)	N/A	N/A	DWS Length (in)	N/A
N/A	Landing X Slope (%)	N/A	N/A	DWS Full Width?	N/A
N/A	Landing Curb? (Y/N)	N/A	N/A	DWS Offset (in)	N/A
N/A	Shared Landing?	N/A			
N/A	Gutter Ponding?	Yes	N/A	Gutter Slope (%)	N/A
N/A	Gutter Lip Ht (in)	N/A	N/A	Gutter X Slope (%)	N/A
N/A	Painted X Walk1?	No	N/A	Painted X Walk2?	N/A
	X Walk 1 Direction	To SE		X Walk 2 Direction	N/A
N/A	X Walk 1 Width (in)	N/A	N/A	X Walk 2 Width (in)	N/A
	X Walk 1 Slope (%)	4.4		X Walk 2 Slope (%)	N/A
	X Walk 1 X Slope (%)	0.6		X Walk 2 X Slope (%)	N/A

N/A	Ramp inside XWalk1?	N/A	N/A	Ramp inside XWalk2?	N/A
	Road Slope (%)	N/A	N/A	Clear Space?	N/A
	Road X Slope (%)	N/A	N/A	Clear Space to XWalk (in)	N/A
N/A	Any Obstructions?	N/A	N/A	Storm Grate/Utility Hazard?	N/A
	Obstruction Type			Storm Grate/Utility Type	
		N/A			N/A
			Yes	Surface Condition? (G/P)	Good

**Remove & Replace Entire Ramp.**

Total Cost: \$ 1850.00
