# Access Compliance Report

## Public Rights-of-Way

### (Curb Ramps)

Intersection ID: 23574	Main Street: CARMEL_RD	Cross Street: QUAIL_HOLLOW_RD	Location: SE
ADA ID: 120C89EF41C8	Ramp Type: Perp	Initial Pass/Fail: Fail	Overall Compliance: No
Severity Score: 12.5			
Codes/Mitigation Info/Possible Solution		Field Measurements/Component Compliance

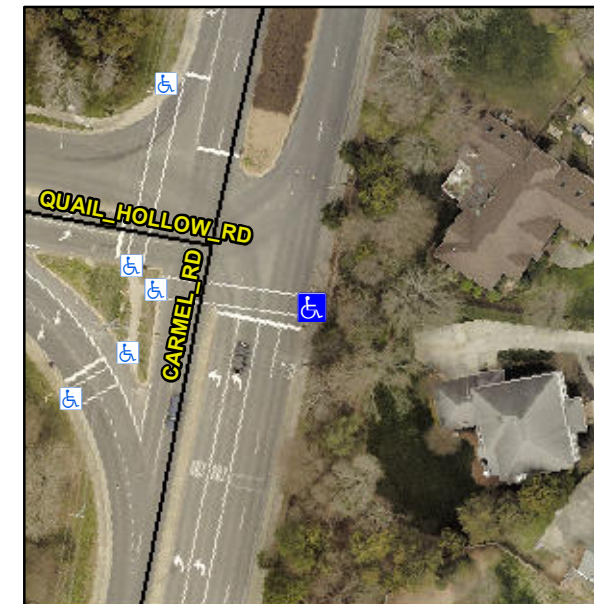
**Not Found, R304.2.2**

Compliance	Description	Data	Compliance	Description	Data
N/A	Ramp Length (in)	58.0	No	Ramp Slope (%)	11.1
Yes	Ramp Width (in)	48.0	Yes	Ramp XSlope (%)	0.8
N/A	Flare Type LT	N/A	N/A	Flare Type RT	N/A
N/A	Flare Slope LT (%)	N/A	N/A	Flare Slope RT (%)	N/A
N/A	Flare Traversable LT?	N/A	N/A	Flare Traversable RT?	N/A
N/A	Landing Length (in)	N/A	N/A	DWS Provided?	N/A
N/A	Landing Width (in)	N/A	N/A	DWS Contrast?	N/A
N/A	Landing Slope (%)	N/A	N/A	DWS Length (in)	N/A
N/A	Landing X Slope (%)	N/A	N/A	DWS Full Width?	N/A
N/A	Landing Curb? (Y/N)	N/A	N/A	DWS Offset (in)	N/A
N/A	Shared Landing?	N/A			
N/A	Gutter Ponding?	N/A	N/A	Gutter Slope (%)	N/A
N/A	Gutter Lip Ht (in)	N/A	N/A	Gutter X Slope (%)	N/A
N/A	Painted X Walk1?	Yes	N/A	Painted X Walk2?	N/A
	X Walk 1 Direction	To NW		X Walk 2 Direction	N/A
N/A	X Walk 1 Width (in)	118.0	N/A	X Walk 2 Width (in)	N/A
	X Walk 1 Slope (%)	2.1		X Walk 2 Slope (%)	N/A
	X Walk 1 X Slope (%)	0.1		X Walk 2 X Slope (%)	N/A

N/A	Ramp inside XWalk1?	Yes	N/A	Ramp inside XWalk2?	N/A
	Road Slope (%)	N/A	N/A	Clear Space?	N/A
	Road X Slope (%)	N/A	N/A	Clear Space to XWalk (in)	N/A
N/A	Any Obstructions?	N/A	N/A	Storm Grate/Utility Hazard?	N/A
	Obstruction Type			Storm Grate/Utility Type	
		N/A			N/A
		Yes		Surface Condition? (G/P)	Good

**Remove & Replace Entire Ramp.**

Total Cost: \$ 1850.00
