# Access Compliance Report

## Public Rights-of-Way

### (Curb Ramps)

Intersection ID: 48863	Main Street: STEELE_CREEK_RD	Cross Street: WALKER_BRANCH_DR	Location: SW
ADA ID: 121BFB590B66	Ramp Type: Perp	Initial Pass/Fail: Fail	Overall Compliance: No
Severity Score: 8.75			
Codes/Mitigation Info/Possible Solution		Field Measurements/Component Compliance

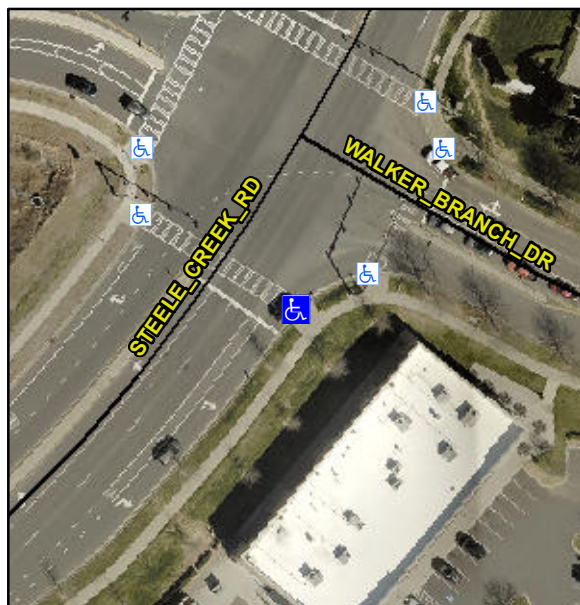
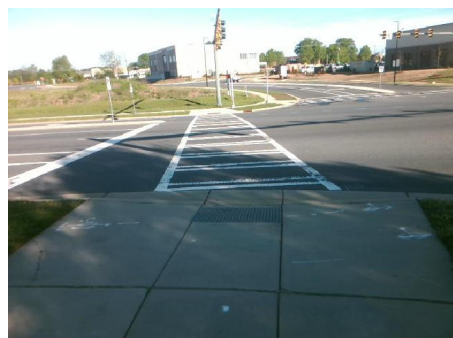
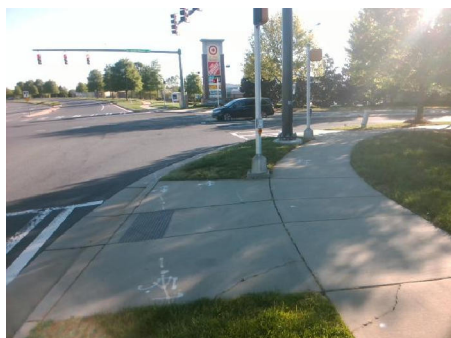
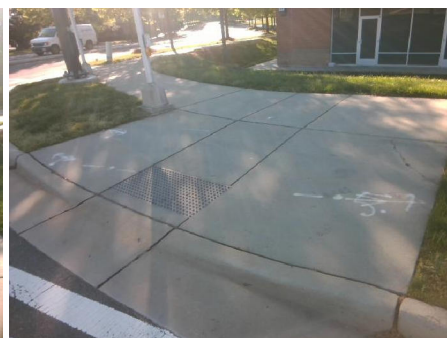
**Not Found, R304.5.1**

Compliance	Description	Data	Compliance	Description	Data
N/A	Ramp Length (in)	95.0	Yes	Ramp Slope (%)	6.2
No	Ramp Width (in)	42.5	Yes	Ramp XSlope (%)	0.3
N/A	Flare Type LT	N/A	N/A	Flare Type RT	N/A
N/A	Flare Slope LT (%)	N/A	N/A	Flare Slope RT (%)	N/A
N/A	Flare Traversable LT?	N/A	N/A	Flare Traversable RT?	N/A
N/A	Landing Length (in)	N/A	N/A	DWS Provided?	N/A
N/A	Landing Width (in)	N/A	N/A	DWS Contrast?	N/A
N/A	Landing Slope (%)	N/A	N/A	DWS Length (in)	N/A
N/A	Landing X Slope (%)	N/A	N/A	DWS Full Width?	N/A
N/A	Landing Curb? (Y/N)	N/A	N/A	DWS Offset (in)	N/A
N/A	Shared Landing?	N/A			
N/A	Gutter Ponding?	N/A	N/A	Gutter Slope (%)	N/A
N/A	Gutter Lip Ht (in)	N/A	N/A	Gutter X Slope (%)	N/A
N/A	Painted X Walk1?	Yes	N/A	Painted X Walk2?	N/A
	X Walk 1 Direction	To NW		X Walk 2 Direction	N/A
N/A	X Walk 1 Width (in)	111.0	N/A	X Walk 2 Width (in)	N/A
	X Walk 1 Slope (%)	1.3		X Walk 2 Slope (%)	N/A
	X Walk 1 X Slope (%)	2.4		X Walk 2 X Slope (%)	N/A

N/A	Ramp inside XWalk1?	Yes	N/A	Ramp inside XWalk2?	N/A
	Road Slope (%)	N/A	N/A	Clear Space?	N/A
	Road X Slope (%)	N/A	N/A	Clear Space to XWalk (in)	N/A
N/A	Any Obstructions?	N/A	N/A	Storm Grate/Utility Hazard?	N/A
	Obstruction Type			Storm Grate/Utility Type	
		N/A			N/A
			Yes	Surface Condition? (G/P)	Good

**Remove & Replace Entire Ramp.**

Total Cost: \$ 1850.00
