## **Access Compliance Report Public Rights-of-Way** (Curb Ramps)

Intersection ID: 52783 Main Street: TAYLOR RIDGE LN **Cross Street: WITHER\_STEELE\_CT** Location: SE ADA ID: 121E93F6F0D7 Ramp Type: Perp Initial Pass/Fail: Fail **Overall Compliance: No Severity Score:** 8.75

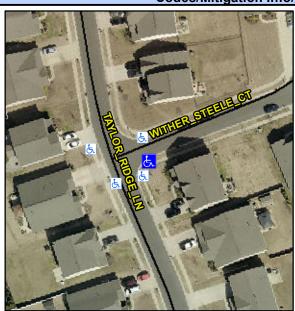
Field Measurements/Component Compliance						
Compliance Description		Data	Comp	liance	Description	Data
N/A	Ramp Length (in)	48.0	Yes	Ram	Slope (%)	5.1
No	Ramp Width (in)	46.5	Yes	s Ramp XSlope (%)		0.5
N/A	Flare Type LT	N/A	N/A	N/A Flare Type RT		N/A
N/A	Flare Slope LT (%)	N/A	N/A	N/A Flare Slope RT (%)		N/A
N/A	Flare Traversable LT?	N/A	N/A	/A Flare Traversable RT?		N/A
N/A	Landing Length (in)	N/A	N/A	DWS	Provided?	N/A
N/A	Landing Width (in)	N/A	N/A	DWS	Contrast?	N/A
N/A	Landing Slope (%)	N/A	N/A	DWS	Length (in)	N/A
N/A	Landing X Slope (%)	N/A	N/A	DWS	Full Width?	N/A
N/A	Landing Curb? (Y/N)	N/A	N/A	DWS	Offset (in)	N/A
N/A	Shared Landing?	N/A				
N/A	Gutter Ponding?	N/A	N/A	Gutte	r Slope (%)	N/A
N/A	Gutter Lip Ht (in)	N/A	N/A	Gutte	er X Slope (%)	N/A
N/A	Painted X Walk1?	No	N/A	Paint	ed X Walk2?	N/A
	X Walk 1 Direction	To N		X Wa	lk 2 Direction	N/A
N/A	X Walk 1 Width (in)	N/A	N/A	X Wa	lk 2 Width (in)	N/A

X Walk 1 Slope (%)	0.8		X Wa	lk 2 Slope (%)	N/A
	X Walk 1 X Slope (%)	0.9		X Wa	lk 2 X Slope (%)	N/A
N/A	Ramp inside XWalk1?	N/A	N/A	Ram	inside XWalk2?	N/A
	Road Slope (%)	N/A	N/A	Clear	Space?	N/A
	Road X Slope (%)	N/A	N/A	Clear	Space to XWalk (in)	N/A
N/A	Any Obstructions?	N/A	N/A	Storn	n Grate/Utility Hazard?	N/A
	Obstruction Type			Storn	n Grate/Utility Type	
		N/A				N/A
			Yes	Surfa	ce Condition? (G/P)	Good
The second

Street 1 Name WITHER STEELE CT Stop Condition-Street 2 StopSign Street 2 Name N/A Stop Condition-Street 1 N/A Possible Solutions: Remove & Replace Entire Ramp. Surveyor Notes: N/A PROW/ADA: Not Found, R304.5.1
