Access Compliance Report

Public Rights-of-Way

(Curb Ramps)

Intersection ID: 26566	Main Street: ARBORHILL_RD	Cross Street: STIRRUP_RIDGE_LN	Location: SE
ADA ID: 121F1E537FD1	Ramp Type: Perp	Initial Pass/Fail: Fail	Overall Compliance: No
Severity Score: 12.5			
Codes/Mitigation Info/Possible Solution		Field Measurements/Component Compliance

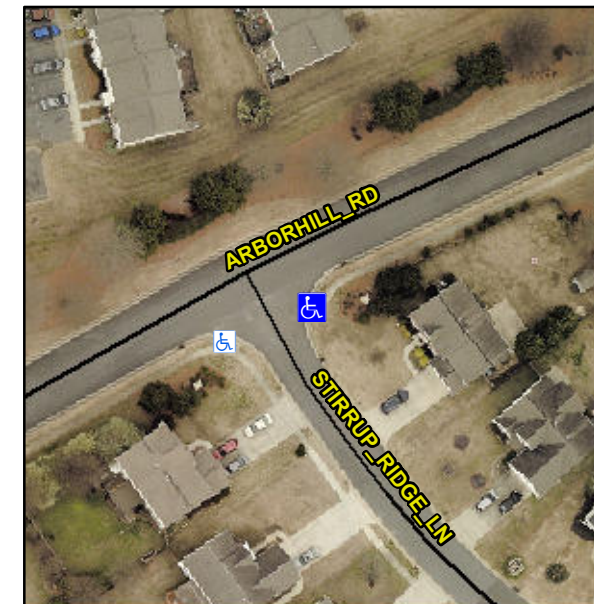
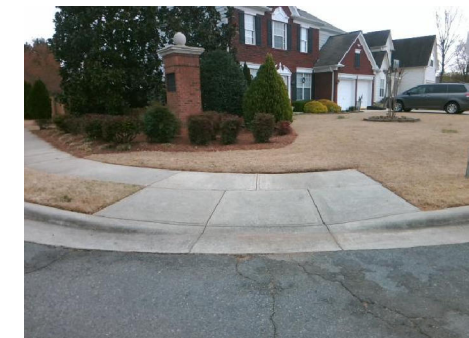
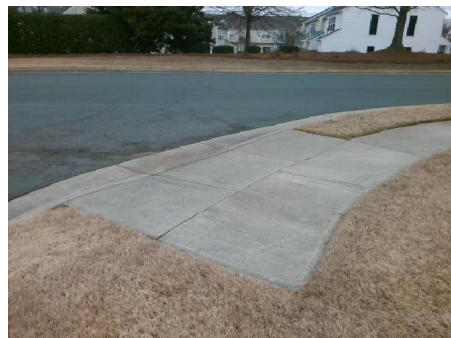
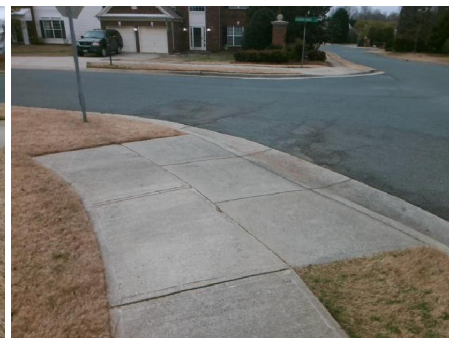
Not Found, R304.2.2

Compliance	Description	Data	Compliance	Description	Data
N/A	Ramp Length (in)	51.0	No	Ramp Slope (%)	11.6
Yes	Ramp Width (in)	51.0	Yes	Ramp XSlope (%)	0.2
N/A	Flare Type LT	N/A	N/A	Flare Type RT	N/A
N/A	Flare Slope LT (%)	N/A	N/A	Flare Slope RT (%)	N/A
N/A	Flare Traversable LT?	N/A	N/A	Flare Traversable RT?	N/A
N/A	Landing Length (in)	N/A	N/A	DWS Provided?	N/A
N/A	Landing Width (in)	N/A	N/A	DWS Contrast?	N/A
N/A	Landing Slope (%)	N/A	N/A	DWS Length (in)	N/A
N/A	Landing X Slope (%)	N/A	N/A	DWS Full Width?	N/A
N/A	Landing Curb? (Y/N)	N/A	N/A	DWS Offset (in)	N/A
N/A	Shared Landing?	N/A			
N/A	Gutter Ponding?	N/A	N/A	Gutter Slope (%)	N/A
N/A	Gutter Lip Ht (in)	N/A	N/A	Gutter X Slope (%)	N/A
N/A	Painted X Walk1?	No	N/A	Painted X Walk2?	N/A
	X Walk 1 Direction	To W		X Walk 2 Direction	N/A
N/A	X Walk 1 Width (in)	N/A	N/A	X Walk 2 Width (in)	N/A
	X Walk 1 Slope (%)	2.5		X Walk 2 Slope (%)	N/A
	X Walk 1 X Slope (%)	0.9		X Walk 2 X Slope (%)	N/A

N/A	Ramp inside XWalk1?	N/A	N/A	Ramp inside XWalk2?	N/A
	Road Slope (%)	N/A	N/A	Clear Space?	N/A
	Road X Slope (%)	N/A	N/A	Clear Space to XWalk (in)	N/A
N/A	Any Obstructions?	N/A	N/A	Storm Grate/Utility Hazard?	N/A
	Obstruction Type			Storm Grate/Utility Type	
		N/A			N/A
			Yes	Surface Condition? (G/P)	Good

Possible Solutions:

Remove & Replace Entire Ramp.
