Access Compliance Report Public Rights-of-Way (Curb Ramps)

Intersection ID: N/A Main Street: E_PROVIDENCE_RD Cross Street: N/A Location: S

ADA ID: 1223E87615D3 Ramp Type: PerpDiag Initial Pass/Fail: Fail Overall Compliance: No Severity Score: 22.5

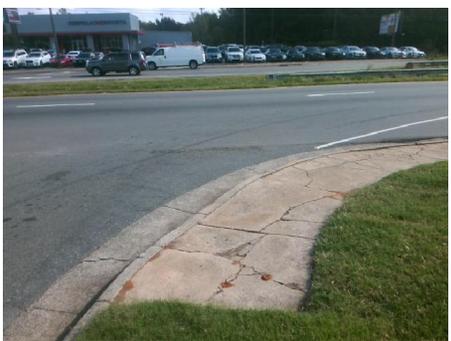
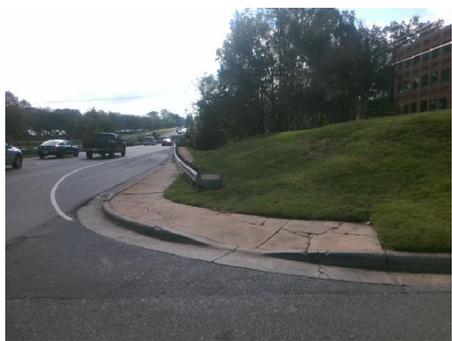
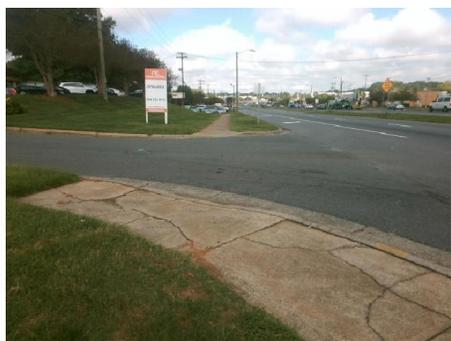
Compliance	Description	Data	Compliance	Description	Data
N/A	Ramp Length (in)	60.0	No	Ramp Slope (%)	11.4
No	Ramp Width (in)	37.0	Yes	Ramp XSlope (%)	3.3
N/A	Flare Type LT	N/A	N/A	Flare Type RT	N/A
N/A	Flare Slope LT (%)	N/A	N/A	Flare Slope RT (%)	N/A
N/A	Flare Traversable LT?	N/A	N/A	Flare Traversable RT?	N/A
N/A	Landing Length (in)	N/A	N/A	DWS Provided?	N/A
N/A	Landing Width (in)	N/A	N/A	DWS Contrast?	N/A
N/A	Landing Slope (%)	N/A	N/A	DWS Length (in)	N/A
N/A	Landing X Slope (%)	N/A	N/A	DWS Full Width?	N/A
N/A	Landing Curb? (Y/N)	N/A	N/A	DWS Offset (in)	N/A
N/A	Shared Landing?	N/A			
N/A	Gutter Ponding?	N/A	N/A	Gutter Slope (%)	N/A
N/A	Gutter Lip Ht (in)	N/A	N/A	Gutter X Slope (%)	N/A
N/A	Painted X Walk1?	No	N/A	Painted X Walk2?	No
	X Walk 1 Direction	To NE		X Walk 2 Direction	To NW
N/A	X Walk 1 Width (in)	N/A	N/A	X Walk 2 Width (in)	N/A
	X Walk 1 Slope (%)	6.5		X Walk 2 Slope (%)	4.9
	X Walk 1 X Slope (%)	0.8		X Walk 2 X Slope (%)	0.2

N/A	Ramp inside XWalk1?	N/A	N/A	Ramp inside XWalk2?	N/A
	Road Slope (%)	5.5	N/A	Clear Space?	N/A
	Road X Slope (%)	5.7	N/A	Clear Space to XWalk (in)	N/A
N/A	Any Obstructions?	N/A	N/A	Storm Grate/Utility Hazard?	N/A
	Obstruction Type			Storm Grate/Utility Type	
			N/A		N/A
			Yes	Surface Condition? (G/P)	Good

Possible Solutions:
Remove & Replace Curb Ramp With Two New Directional Ramps or Equivalent.
