Intersection ID: 13802		Main Street: LEXINGTON_AV		Cross Street: MYRTLE_AV		Location:		E			
ADA ID: 122BA1F279F4		Ramp Type: Directional1		Initial Pass/Fail: Fail		Overall Compliance: No		Severity Score: 1.25			
Codes/Mitigation Info/Possible Solution				Field Measurements/Component Compliance							
<div>

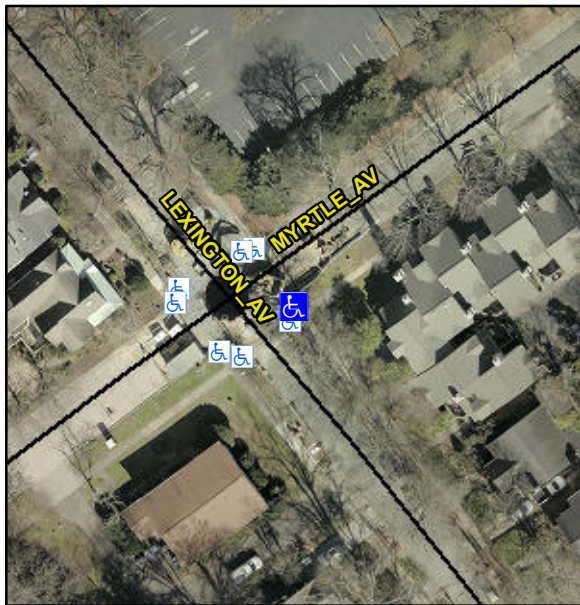
</div> <div>Street 1 NameMYRTLE AV Stop Condition-Street 1StopSign Street 2 NameN/A Stop Condition-Street 2N/A</div>				Possible Solutions:		Compliance		Description		Data	
				Remove & Replace Entire Ramp.		N/A		Ramp Length (in)		24.0	
<div>Surveyor Notes: ASP LIP 1.0"</div> <div>PROW/ADA: R304.5.3</div>				Yes		Ramp Width (in)		60.0			
				Yes		Ramp Slope (%)		7.2			
				No		Ramp XSlope (%)		2.7			
				N/A		Flare Type LT		N/A			
				N/A		Flare Slope LT (%)		N/A			
				N/A		Flare Traversable LT?		N/A			
				N/A		Landing Length (in)		0.0			
				N/A		Landing Width (in)		0.0			
				N/A		Landing Slope (%)		0.0

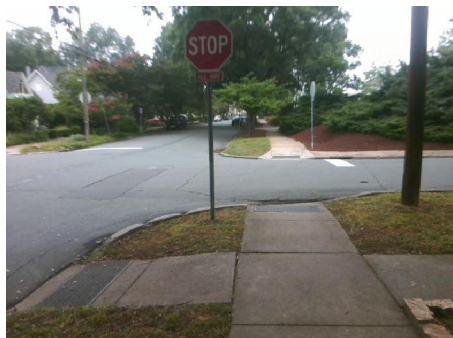
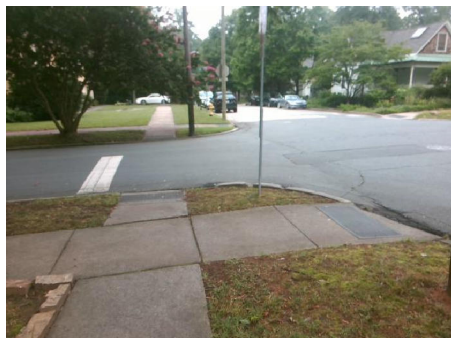
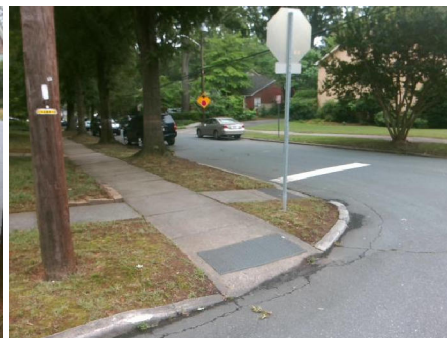
N/A		Landing X Slope (%)		0.0			
				N/A		Landing Curb? (Y/N)		N/A			
				N/A		Shared Landing?		N/A			
				N/A		Gutter Ponding?		0.0			
				N/A		Gutter Lip Ht (in)		0.0			
				N/A		Painted X Walk1?		No			
						X Walk 1 Direction		To NW			
						X Walk 1 Width (in)		N/A			
						X Walk 1 Slope (%)		5.3			
						X Walk 1 X Slope (%)		3.1			
				N/A		Ramp inside XWalk1?		N/A			
				N/A		Any Obstructions?		N/A			
						Obstruction Type		Yes			
Total Cost: \$ 1600.00						Surface Condition? (G/P)		Good			
						Curb Slope (%)		N/A			
						Grade Break?		N/A			
						Grade Break Slope (%)		0.0			
						Grade Break XSlope (%)		0.0			
						Flare Type RT		N/A			
						Flare Slope RT (%)		0.0			
						Flare Traversable RT?		N/A			
						DWS Provided?		N/A			
						DWS Contrast?		N/A			
						DWS Length (in)		N/A			
						DWS Full Width?		N/A			
						DWS Offset LT (in)		N/A			
						DWS Offset RT (in)		N/A			
						Gutter Slope (%)		N/A

Gutter X Slope (%)		N/A			
						Road Slope (%)		5.3			
						Road X Slope (%)		3.1			
						Clear Space?		N/A			
						Clear Space to XWalk (in)		N/A			
						Storm Grate/Utility Hazard?		N/A			
						Storm Grate/Utility Type					
								N/A
