Access Compliance Report

Public Rights-of-Way

(Curb Ramps)

Intersection ID: 10036062	Main Street: RIVERGATE_PY	Cross Street: N/A	Location: NE
ADA ID: 122E7C386FDC	Ramp Type: Perp	Initial Pass/Fail: Fail	Overall Compliance: No
Severity Score: 13.75			
Codes/Mitigation Info/Possible Solution		Field Measurements/Component Compliance

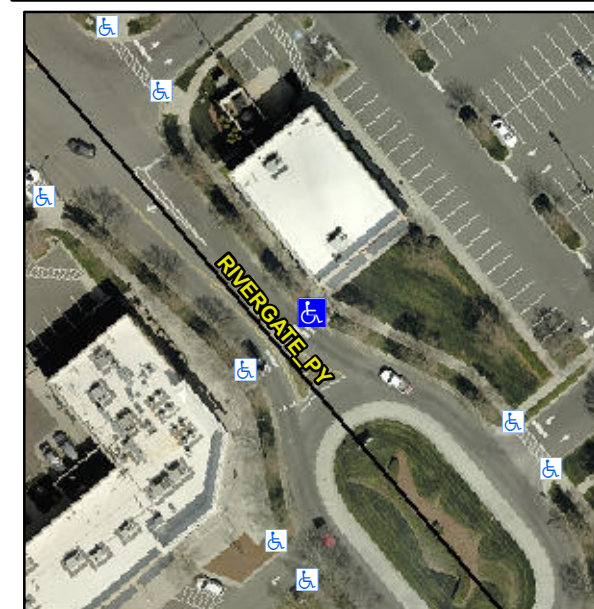
Not Found, R304.2.2, R304.5.3

Compliance	Description	Data	Compliance	Description	Data
N/A	Ramp Length (in)	94.0	No	Ramp Slope (%)	8.5
Yes	Ramp Width (in)	48.0	No	Ramp XSlope (%)	2.4
N/A	Flare Type LT	N/A	N/A	Flare Type RT	N/A
N/A	Flare Slope LT (%)	N/A	N/A	Flare Slope RT (%)	N/A
N/A	Flare Traversable LT?	N/A	N/A	Flare Traversable RT?	N/A
N/A	Landing Length (in)	N/A	N/A	DWS Provided?	N/A
N/A	Landing Width (in)	N/A	N/A	DWS Contrast?	N/A
N/A	Landing Slope (%)	N/A	N/A	DWS Length (in)	N/A
N/A	Landing X Slope (%)	N/A	N/A	DWS Full Width?	N/A
N/A	Landing Curb? (Y/N)	N/A	N/A	DWS Offset (in)	N/A
N/A	Shared Landing?	N/A			
N/A	Gutter Ponding?	N/A	N/A	Gutter Slope (%)	N/A
N/A	Gutter Lip Ht (in)	N/A	N/A	Gutter X Slope (%)	N/A
N/A	Painted X Walk1?	Yes	N/A	Painted X Walk2?	N/A
	X Walk 1 Direction	To SW		X Walk 2 Direction	N/A
N/A	X Walk 1 Width (in)	120.0	N/A	X Walk 2 Width (in)	N/A
	X Walk 1 Slope (%)	2.9		X Walk 2 Slope (%)	N/A
	X Walk 1 X Slope (%)	2.0		X Walk 2 X Slope (%)	N/A

N/A	Ramp inside XWalk1?	Yes	N/A	Ramp inside XWalk2?	N/A
	Road Slope (%)	N/A	N/A	Clear Space?	N/A
	Road X Slope (%)	N/A	N/A	Clear Space to XWalk (in)	N/A
N/A	Any Obstructions?	N/A	N/A	Storm Grate/Utility Hazard?	N/A
	Obstruction Type			Storm Grate/Utility Type	
		N/A			N/A
			Yes	Surface Condition? (G/P)	Good

Possible Solutions:

Remove & Replace Entire Ramp.

Total Cost: \$ 1850.00
