Access Compliance Report

Public Rights-of-Way

(Curb Ramps)

Intersection ID: 14033	Main Street: ELMIN_ST	Cross Street: MORNING_DR	Location: SE
ADA ID: 12488C12E0DC	Ramp Type: Combination2Diag	Initial Pass/Fail: Fail	Overall Compliance: No
		Severity Score: 0

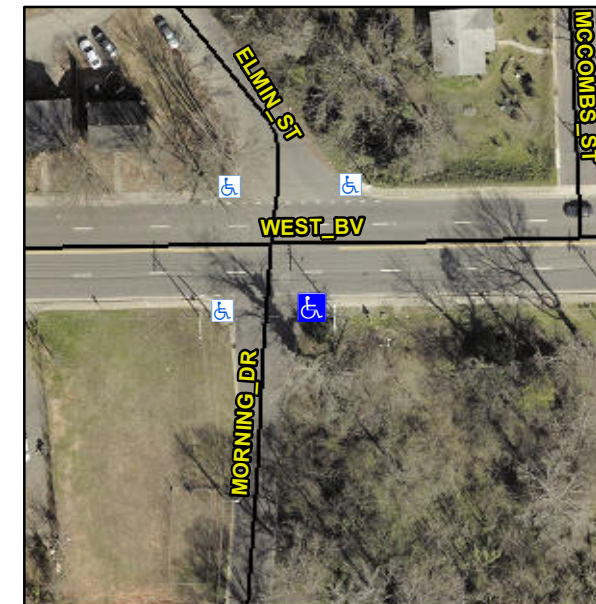
Compliance	Description	Data	Compliance	Description	Data
N/A	Ramp Length LT (in)	N/A	N/A	Ramp Length RT (in)	49.0
N/A	Ramp Width LT (in)	N/A	Yes	Ramp Width RT (in)	49.0
N/A	Ramp Slope LT (%)	N/A	No	Ramp Slope RT (%)	10.2
N/A	Ramp XSlope LT (%)	N/A	No	Ramp XSlope RT (%)	2.6
N/A	Ramp Length (in)	49.5	Yes	Ramp Slope (%)	4.8
No	Ramp Width (in)	42.0	Yes	Ramp XSlope (%)	2.7
N/A	Flare Type LT	N/A	N/A	Flare Type RT	N/A
N/A	Flare Slope LT (%)	N/A	N/A	Flare Slope RT (%)	N/A
N/A	Flare Traversable LT?	N/A	N/A	Flare Traversable RT?	N/A
N/A	Landing Length (in)	N/A	N/A	DWS Provided?	N/A
N/A	Landing Width (in)	N/A	N/A	DWS Contrast?	N/A
N/A	Landing Slope (%)	N/A	N/A	DWS Length (in)	N/A
N/A	Landing X Slope (%)	N/A	N/A	DWS Full Width?	N/A
N/A	Landing Curb? (Y/N)	N/A	N/A	DWS Offset (in)	N/A
N/A	Shared Landing?	N/A			
N/A	Gutter Ponding?	N/A	N/A	Gutter Slope (%)	N/A
N/A	Gutter Lip Ht (in)	N/A	N/A	Gutter X Slope (%)	N/A
N/A	Painted X Walk1?	No	N/A	Painted X Walk2?	No

X Walk 1 Direction	To N		X Walk 2 Direction	To W
	X Walk 1 Width (in)	N/A		X Walk 2 Width (in)	N/A
	X Walk 1 Slope (%)	1.4		X Walk 2 Slope (%)	4.5
	X Walk 1 X Slope (%)	2.2		X Walk 2 X Slope (%)	2.6
N/A	Ramp inside XWalk1?	N/A	N/A	Ramp inside XWalk2?	N/A
	Road Slope (%)	3.0		Clear Space?	N/A
	Road X Slope (%)	2.2	N/A	Clear Space to XWalk (in)	N/A
			N/A	Any Obstruction?	N/A
				Obstruction Type	N/A
			N/A	Storm Grate/Utility Hazard?	N/A
				Storm Grate/Utility Type	N/A
Yes	Surface Condition? (G/P)	Good			
	Curb Slope (%)	0.7

Remove & Replace Curb Ramp With Two New Directional Ramps or Equivalent.
