# Access Compliance Report

## Public Rights-of-Way

### (Curb Ramps)

Intersection ID: 32211	Main Street: DENNINGTON GROVE LN	Cross Street: BRYANT FARMS RD	Location: NE
ADA ID: 12532A518D3B	Ramp Type: PerpDiag	Initial Pass/Fail: Fail	Overall Compliance: No
Severity Score: 10			
Codes/Mitigation Info/Possible Solution		Field Measurements/Component Compliance

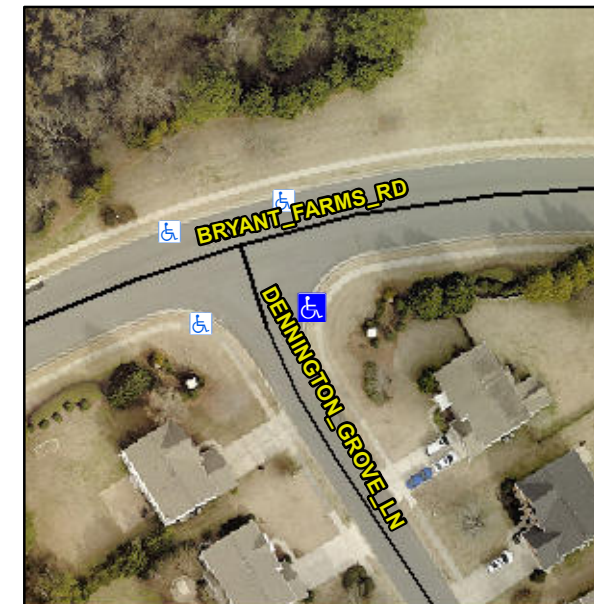
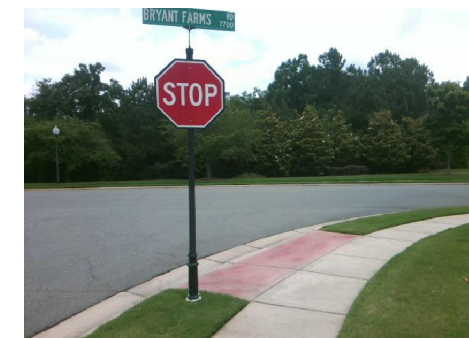
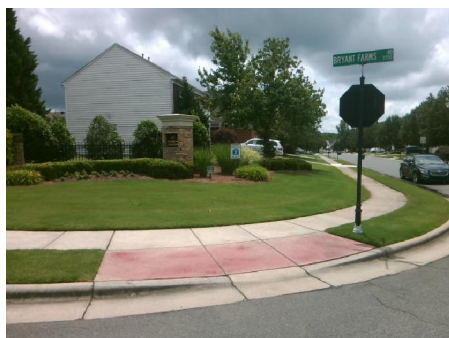
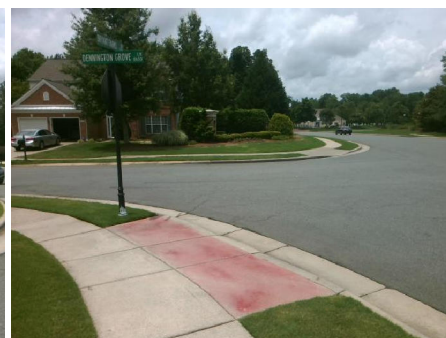
**Not Found, R304.5.1, R304.5.3**

Compliance	Description	Data	Compliance	Description	Data
N/A	Ramp Length (in)	80.0	Yes	Ramp Slope (%)	7.5
No	Ramp Width (in)	41.0	No	Ramp XSlope (%)	2.5
N/A	Flare Type LT	N/A	N/A	Flare Type RT	N/A
N/A	Flare Slope LT (%)	N/A	N/A	Flare Slope RT (%)	N/A
N/A	Flare Traversable LT?	N/A	N/A	Flare Traversable RT?	N/A
N/A	Landing Length (in)	N/A	N/A	DWS Provided?	N/A
N/A	Landing Width (in)	N/A	N/A	DWS Contrast?	N/A
N/A	Landing Slope (%)	N/A	N/A	DWS Length (in)	N/A
N/A	Landing X Slope (%)	N/A	N/A	DWS Full Width?	N/A
N/A	Landing Curb? (Y/N)	N/A	N/A	DWS Offset (in)	N/A
N/A	Shared Landing?	N/A			
N/A	Gutter Ponding?	N/A	N/A	Gutter Slope (%)	N/A
N/A	Gutter Lip Ht (in)	N/A	N/A	Gutter X Slope (%)	N/A
N/A	Painted X Walk1?	No	N/A	Painted X Walk2?	No
	X Walk 1 Direction	To N		X Walk 2 Direction	To W
N/A	X Walk 1 Width (in)	N/A	N/A	X Walk 2 Width (in)	N/A
	X Walk 1 Slope (%)	4.6		X Walk 2 Slope (%)	0.5
	X Walk 1 X Slope (%)	0.3		X Walk 2 X Slope (%)	2.7

N/A	Ramp inside XWalk1?	N/A	N/A	Ramp inside XWalk2?	N/A
	Road Slope (%)	3.0	N/A	Clear Space?	N/A
	Road X Slope (%)	2.2	N/A	Clear Space to XWalk (in)	N/A
N/A	Any Obstructions?	N/A	N/A	Storm Grate/Utility Hazard?	N/A
	Obstruction Type			Storm Grate/Utility Type	
		N/A			N/A
		Yes		Surface Condition? (G/P)	Good

**Remove & Replace Curb Ramp With Two New Directional Ramps or Equivalent.**
