# Access Compliance Report

## Public Rights-of-Way

### (Curb Ramps)

| ADA ID: 12545D6D7C40 | Ramp Type: PerpDiag | Initial Pass/Fail: Fail | Overall Compliance: No |

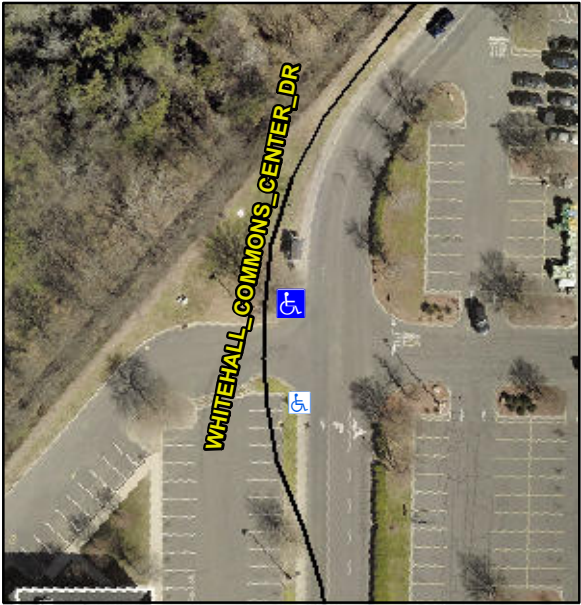
| Severity Score: 21.25 | | | |

| | Remove & Replace Curb Ramp With Two New Directional Ramps or Equivalent. | | N/A | | Ramp Length (in) | | 24.0 | No | Ramp Slope (%) | 9.0 |
| <p>Surveyor Notes:</p> <p>N/A</p> <p>PROW/ADA:</p> <p>Not Found, R304.5.1, R304.2.2</p> | | | No | | Ramp Width (in) | | 44.0 | Yes | Ramp XSlope (%) | 1.5 |

| <p>Total Cost:</p> <p>\$ 3200.00</p> | | | N/A | | Landing Length (in) | | N/A | N/A | DWS Provided? | N/A |
