# Access Compliance Report

## Public Rights-of-Way

| Intersection ID: 26515 | Main Street: JOHNSTON_RD | Cross Street: PORTERFIELD_RD | Location: SW |
| ADA ID: 12549E06216E | Ramp Type: PerpDiag | Initial Pass/Fail: Fail | Overall Compliance: No |

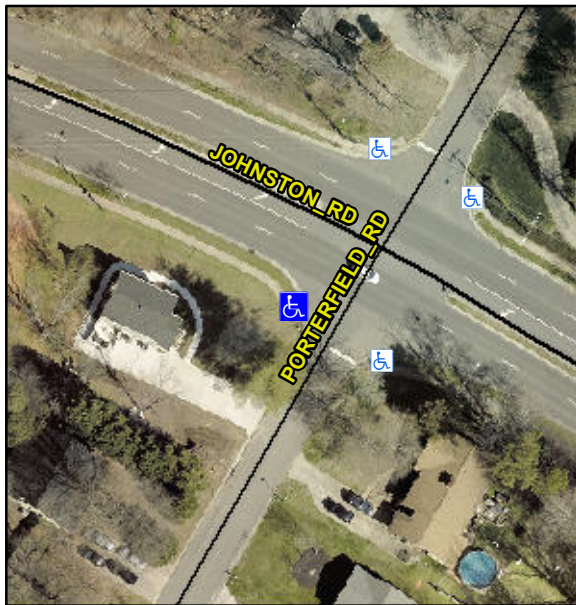
| | | | Severity Score: 21.25 |

**Not Found, R304.5.1, R304.2.2**

| Compliance | Description | Data | Compliance | Description | Data |
|---|---|---|---|---|---|
| N/A | Ramp Length (in) | 59.0 | No | Ramp Slope (%) | 10.7 |
| No | Ramp Width (in) | 40.0 | Yes | Ramp XSlope (%) | 1.3 |

**Remove & Replace Curb Ramp With Two New Directional Ramps or Equivalent.**

Total Cost: \$ **3200.00**
