Access Compliance Report

Public Rights-of-Way

(Curb Ramps)

Intersection ID: N/A	Main Street: DIXIE_RIVER_RD	Cross Street: INVERNESS_BAY_RD	Location: NW
ADA ID: 126483467D7B	Ramp Type: PerpDiag	Initial Pass/Fail: Fail	Overall Compliance: No
		Severity Score: 10

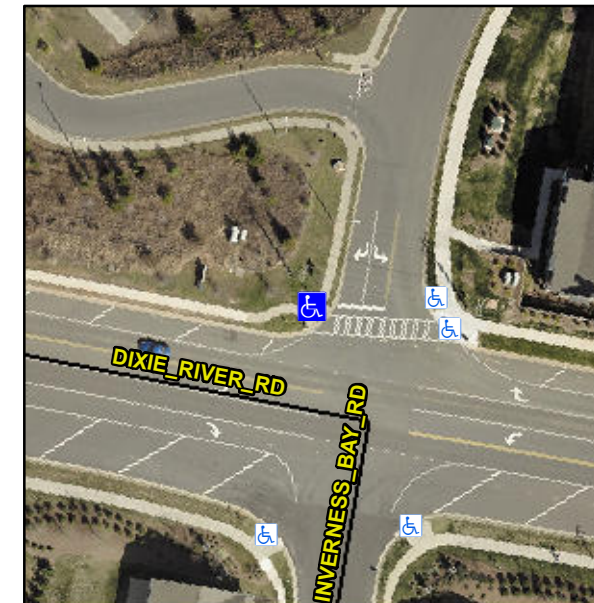
Compliance	Description	Data	Compliance	Description	Data
N/A	Ramp Length (in)	42.0	Yes	Ramp Slope (%)	5.5
No	Ramp Width (in)	43.0	No	Ramp XSlope (%)	4.8
N/A	Flare Type LT	N/A	N/A	Flare Type RT	N/A
N/A	Flare Slope LT (%)	N/A	N/A	Flare Slope RT (%)	N/A
N/A	Flare Traversable LT?	N/A	N/A	Flare Traversable RT?	N/A
N/A	Landing Length (in)	N/A	N/A	DWS Provided?	N/A
N/A	Landing Width (in)	N/A	N/A	DWS Contrast?	N/A
N/A	Landing Slope (%)	N/A	N/A	DWS Length (in)	N/A
N/A	Landing X Slope (%)	N/A	N/A	DWS Full Width?	N/A
N/A	Landing Curb? (Y/N)	N/A	N/A	DWS Offset (in)	N/A
N/A	Shared Landing?	N/A			
N/A	Gutter Ponding?	N/A	N/A	Gutter Slope (%)	N/A
N/A	Gutter Lip Ht (in)	N/A	N/A	Gutter X Slope (%)	N/A
N/A	Painted X Walk1?	No	N/A	Painted X Walk2?	Yes
	X Walk 1 Direction	To S		X Walk 2 Direction	To E
N/A	X Walk 1 Width (in)	N/A	N/A	X Walk 2 Width (in)	102.0
	X Walk 1 Slope (%)	0.9		X Walk 2 Slope (%)	0.0
	X Walk 1 X Slope (%)	1.3		X Walk 2 X Slope (%)	3.5

N/A	Ramp inside XWalk1?	N/A	N/A	Ramp inside XWalk2?	Yes
	Road Slope (%)	1.7	N/A	Clear Space?	N/A
	Road X Slope (%)	1.6	N/A	Clear Space to XWalk (in)	N/A
N/A	Any Obstructions?	N/A	N/A	Storm Grate/Utility Hazard?	N/A
	Obstruction Type			Storm Grate/Utility Type	
		N/A			N/A
			Yes	Surface Condition? (G/P)	Good

Remove & Replace Curb Ramp With Two New Directional Ramps or Equivalent.

R304.5.1, R304.5.3
