Access Compliance Report

Public Rights-of-Way

(Curb Ramps)

Intersection ID: 2626	Main Street: FAIRVISTA_DR	Cross Street: MOONLIGHT_LN	Location: S
ADA ID: 127864F723F4	Ramp Type: PerpDiag	Initial Pass/Fail: Fail	Overall Compliance: No
Codes/Mitigation Info/Possible Solution		Field Measurements/Component Compliance	
Severity Score: 58.75

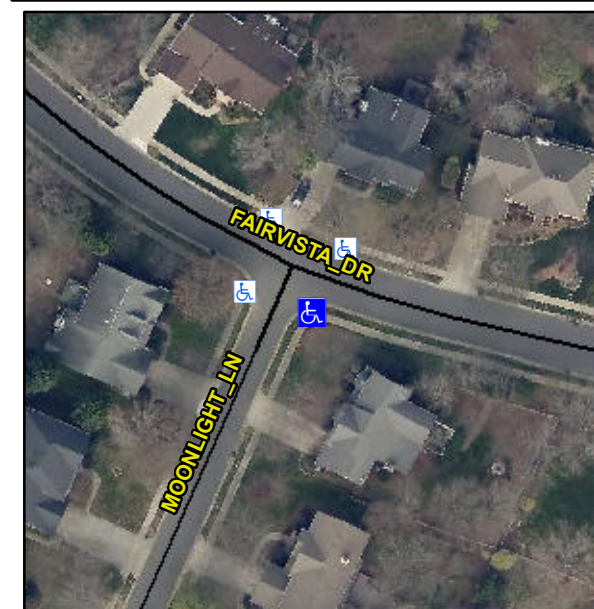
Not Found, R304.5.1, R304.2.2, R304.5.3

Compliance	Description	Data	Compliance	Description	Data
N/A	Ramp Length (in)	47.0	No	Ramp Slope (%)	15.5
No	Ramp Width (in)	40.5	No	Ramp XSlope (%)	8.2
N/A	Flare Type LT	N/A	N/A	Flare Type RT	N/A
N/A	Flare Slope LT (%)	N/A	N/A	Flare Slope RT (%)	N/A
N/A	Flare Traversable LT?	N/A	N/A	Flare Traversable RT?	N/A
N/A	Landing Length (in)	N/A	N/A	DWS Provided?	N/A
N/A	Landing Width (in)	N/A	N/A	DWS Contrast?	N/A
N/A	Landing Slope (%)	N/A	N/A	DWS Length (in)	N/A
N/A	Landing X Slope (%)	N/A	N/A	DWS Full Width?	N/A
N/A	Landing Curb? (Y/N)	N/A	N/A	DWS Offset (in)	N/A
N/A	Shared Landing?	N/A			
N/A	Gutter Ponding?	N/A	N/A	Gutter Slope (%)	N/A
N/A	Gutter Lip Ht (in)	N/A	N/A	Gutter X Slope (%)	N/A
N/A	Painted X Walk1?	No	N/A	Painted X Walk2?	No
	X Walk 1 Direction	To NE		X Walk 2 Direction	To NW
N/A	X Walk 1 Width (in)	N/A	N/A	X Walk 2 Width (in)	N/A
	X Walk 1 Slope (%)	0.5		X Walk 2 Slope (%)	5.9
	X Walk 1 X Slope (%)	7.3		X Walk 2 X Slope (%)	3.4

N/A	Ramp inside XWalk1?	N/A	N/A	Ramp inside XWalk2?	N/A
	Road Slope (%)	5.6	N/A	Clear Space?	N/A
	Road X Slope (%)	3.4	N/A	Clear Space to XWalk (in)	N/A
N/A	Any Obstructions?	N/A	N/A	Storm Grate/Utility Hazard?	N/A
	Obstruction Type			Storm Grate/Utility Type	
		N/A			N/A
			Yes	Surface Condition? (G/P)	Good

Possible Solutions:

Remove & Replace Curb Ramp With Two New Directional Ramps or Equivalent.
