Access Compliance Report

Public Rights-of-Way

(Curb Ramps)

Intersection ID: 26025	Main Street: CARMEL_RD	Cross Street: CARMEL_COMMONS_BV	Location: SE
ADA ID: 1281CE3E98FA	Ramp Type: Para	Initial Pass/Fail: Fail	Overall Compliance: No
Severity Score: 12.5			
Codes/Mitigation Info/Possible Solution		Field Measurements/Component Compliance

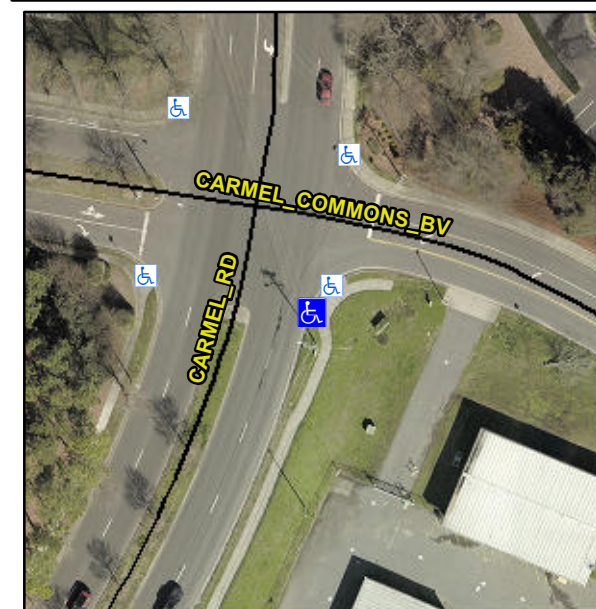
PROW/ADA:

R304.3.2

Compliance	Description	Data	Compliance	Description	Data
N/A	Ramp Length LT (in)	N/A	N/A	Ramp Length RT (in)	43.0
N/A	Ramp Width LT (in)	N/A	Yes	Ramp Width RT (in)	71.0
N/A	Ramp Slope LT (%)	N/A	No	Ramp Slope RT (%)	9.5
N/A	Ramp XSlope LT (%)	N/A	Yes	Ramp XSlope RT (%)	0.7
N/A	Landing Length (in)	N/A	N/A	DWS Provided?	N/A
N/A	Landing Width (in)	N/A	N/A	DWS Contrast?	N/A
N/A	Landing Slope (%)	N/A	N/A	DWS Length (in)	N/A
N/A	Landing X Slope (%)	N/A	N/A	DWS Full Width?	N/A
N/A	Landing Curb? (Y/N)	N/A	N/A	DWS Offset (in)	N/A
N/A	Shared Landing?	N/A			
N/A	Gutter Ponding?	N/A	N/A	Gutter Slope (%)	N/A
N/A	Gutter Lip Ht (in)	N/A	N/A	Gutter X Slope (%)	N/A
N/A	Painted X Walk1?	No	N/A	Painted X Walk2?	N/A
	X Walk 1 Direction	To NW		X Walk 2 Direction	N/A
N/A	X Walk 1 Width (in)	N/A	N/A	X Walk 2 Width (in)	N/A
	X Walk 1 Slope (%)	0.7		X Walk 2 Slope (%)	N/A
	X Walk 1 X Slope (%)	1.6		X Walk 2 X Slope (%)	N/A
N/A	Ramp inside XWalk1?	N/A	N/A	Ramp inside XWalk2?	N/A

Road Slope (%)	N/A	N/A	Clear Space?	N/A
	Road X Slope (%)	N/A	N/A	Clear Space to XWalk (in)	N/A
N/A	Any Obstructions?	N/A	N/A	Storm Grate/Utility Hazard?	N/A
	Obstruction Type			Storm Grate/Utility Type	
		N/A			N/A
			Yes	Surface Condition? (G/P)	Good
			N/A	Curb Slope (%)	8.1

Possible Solutions:

Remove & Replace Entire Ramp.
