# Access Compliance Report

## Public Rights-of-Way

### (Curb Ramps)

| Intersection ID: 10018047 | Main Street: BROOKSTEAD MEADOW CT | Cross Street: N/A | Location: SE |

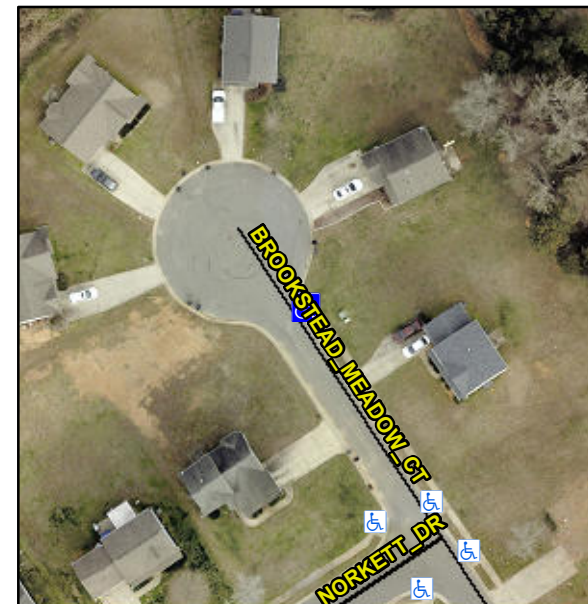
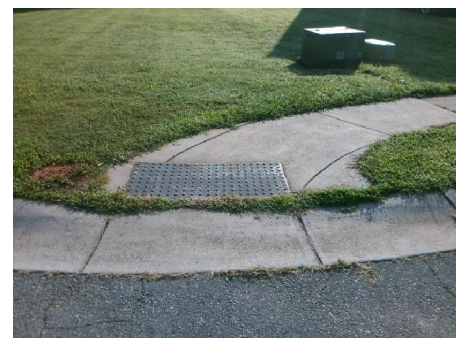
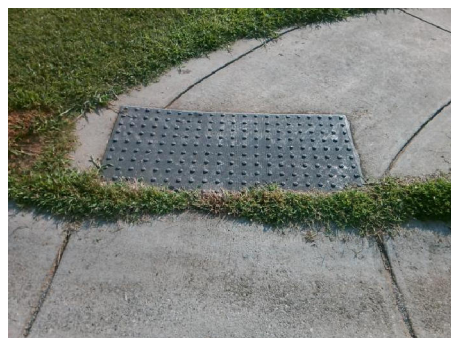
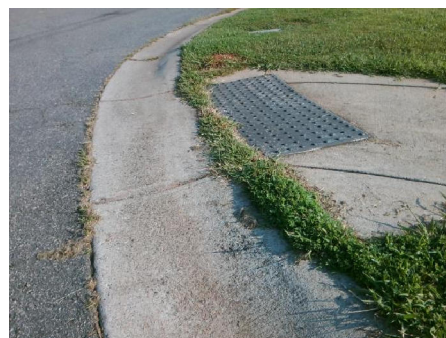
| ADA ID: 1290DE387C69 | Ramp Type: BlendTrans1 | Initial Pass/Fail: Fail | Overall Compliance: No |
| Severity Score: 8.75 | | | |

| Compliance | Description | Data | Compliance | Description | Data |
|---|---|---|---|---|---|
| No | Ramp Width (in) | 46.5 | Yes | BlendTrans XSlope (%) | 1.3 |

**Remove & Replace Curb Ramp With Two New Directional Ramps or Equivalent.**

**R304.5.1**
