Access Compliance Report

Public Rights-of-Way

(Curb Ramps)

Intersection ID: 4312	Main Street: RADBOURNE BV	Cross Street: W W T HARRIS BV	Location: NW
ADA ID: 1290F55CC24E	Ramp Type: Perp	Initial Pass/Fail: Fail	Overall Compliance: No
			Severity Score: 40

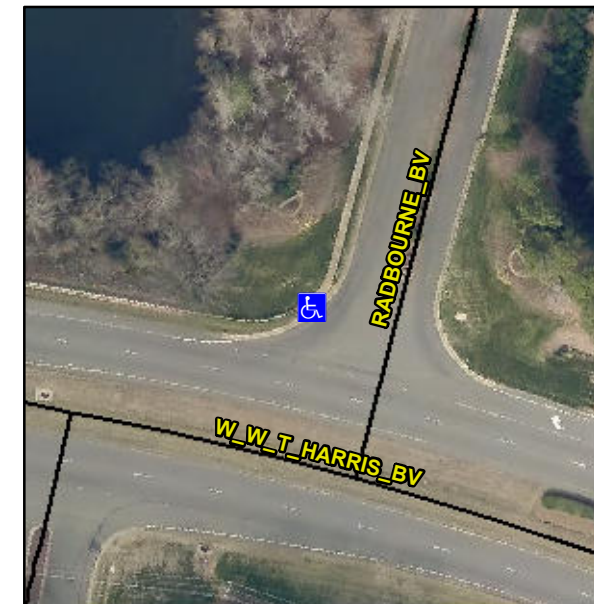
R304.2.2, R304.5.3, R302.7

Compliance	Description	Data	Compliance	Description	Data
N/A	Ramp Length (in)	60.5	No	Ramp Slope (%)	11.1
Yes	Ramp Width (in)	48.0	No	Ramp XSlope (%)	5.7
N/A	Flare Type LT	N/A	N/A	Flare Type RT	N/A
N/A	Flare Slope LT (%)	N/A	N/A	Flare Slope RT (%)	N/A
N/A	Flare Traversable LT?	N/A	N/A	Flare Traversable RT?	N/A
N/A	Landing Length (in)	N/A	N/A	DWS Provided?	N/A
N/A	Landing Width (in)	N/A	N/A	DWS Contrast?	N/A
N/A	Landing Slope (%)	N/A	N/A	DWS Length (in)	N/A
N/A	Landing X Slope (%)	N/A	N/A	DWS Full Width?	N/A
N/A	Landing Curb? (Y/N)	N/A	N/A	DWS Offset (in)	N/A
N/A	Shared Landing?	N/A			
N/A	Gutter Ponding?	N/A	N/A	Gutter Slope (%)	N/A
N/A	Gutter Lip Ht (in)	N/A	N/A	Gutter X Slope (%)	N/A
N/A	Painted X Walk1?	No	N/A	Painted X Walk2?	N/A
	X Walk 1 Direction	To SE		X Walk 2 Direction	N/A
N/A	X Walk 1 Width (in)	N/A	N/A	X Walk 2 Width (in)	N/A
	X Walk 1 Slope (%)	1.5		X Walk 2 Slope (%)	N/A
	X Walk 1 X Slope (%)	6.9		X Walk 2 X Slope (%)	N/A

N/A	Ramp inside XWalk1?	N/A	N/A	Ramp inside XWalk2?	N/A
	Road Slope (%)	N/A	N/A	Clear Space?	N/A
	Road X Slope (%)	N/A	N/A	Clear Space to XWalk (in)	N/A
N/A	Any Obstructions?	N/A	N/A	Storm Grate/Utility Hazard?	N/A
	Obstruction Type			Storm Grate/Utility Type	
		N/A			N/A
		No		Surface Condition? (G/P)	Poor

Possible Solutions:

Remove & Replace Entire Ramp.
