Access Compliance Report

Public Rights-of-Way

(Curb Ramps)

Intersection ID: 10022357	Main Street: CAMERON_VALLEY_PY	Cross Street: N/A	Location: NE
ADA ID: 12A2BCED8DCE	Ramp Type: PerpDiag	Initial Pass/Fail: Fail	Overall Compliance: No
Severity Score: 33.75			
Codes/Mitigation Info/Possible Solution		Field Measurements/Component Compliance

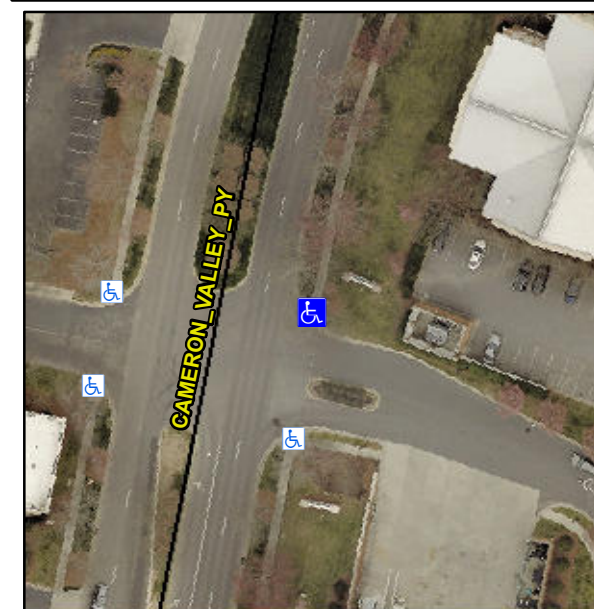
Not Found, R304.5.1, R304.2.2, R304.5.3

Compliance	Description	Data	Compliance	Description	Data
N/A	Ramp Length (in)	57.0	No	Ramp Slope (%)	10.2
No	Ramp Width (in)	37.5	No	Ramp XSlope (%)	6.8
N/A	Flare Type LT	N/A	N/A	Flare Type RT	N/A
N/A	Flare Slope LT (%)	N/A	N/A	Flare Slope RT (%)	N/A
N/A	Flare Traversable LT?	N/A	N/A	Flare Traversable RT?	N/A
N/A	Landing Length (in)	N/A	N/A	DWS Provided?	N/A
N/A	Landing Width (in)	N/A	N/A	DWS Contrast?	N/A
N/A	Landing Slope (%)	N/A	N/A	DWS Length (in)	N/A
N/A	Landing X Slope (%)	N/A	N/A	DWS Full Width?	N/A
N/A	Landing Curb? (Y/N)	N/A	N/A	DWS Offset (in)	N/A
N/A	Shared Landing?	N/A			
N/A	Gutter Ponding?	N/A	N/A	Gutter Slope (%)	N/A
N/A	Gutter Lip Ht (in)	N/A	N/A	Gutter X Slope (%)	N/A
N/A	Painted X Walk1?	No	N/A	Painted X Walk2?	No
	X Walk 1 Direction	To NW		X Walk 2 Direction	To SW
N/A	X Walk 1 Width (in)	N/A	N/A	X Walk 2 Width (in)	N/A
	X Walk 1 Slope (%)	2.7		X Walk 2 Slope (%)	2.6
	X Walk 1 X Slope (%)	5.3		X Walk 2 X Slope (%)	4.5

N/A	Ramp inside XWalk1?	N/A	N/A	Ramp inside XWalk2?	N/A
	Road Slope (%)	6.0	N/A	Clear Space?	N/A
	Road X Slope (%)	1.7	N/A	Clear Space to XWalk (in)	N/A
N/A	Any Obstructions?	N/A	N/A	Storm Grate/Utility Hazard?	N/A
	Obstruction Type			Storm Grate/Utility Type	
		N/A			N/A
			Yes	Surface Condition? (G/P)	Good

Remove & Replace Curb Ramp With Two New Directional Ramps or Equivalent.

Total Cost: \$ 3200.00
