Access Compliance Report

Public Rights-of-Way

(Curb Ramps)

Intersection ID: N/A	Main Street: BEREWICK_TOWN_CENTRE	Cross Street: N/A	Location: NE
ADA ID: 12A6B9C9EB40	Ramp Type: BlendTrans1	Initial Pass/Fail: Fail	Overall Compliance: No
Severity Score: 1.25			
Codes/Mitigation Info/Possible Solution		Field Measurements/Component Compliance

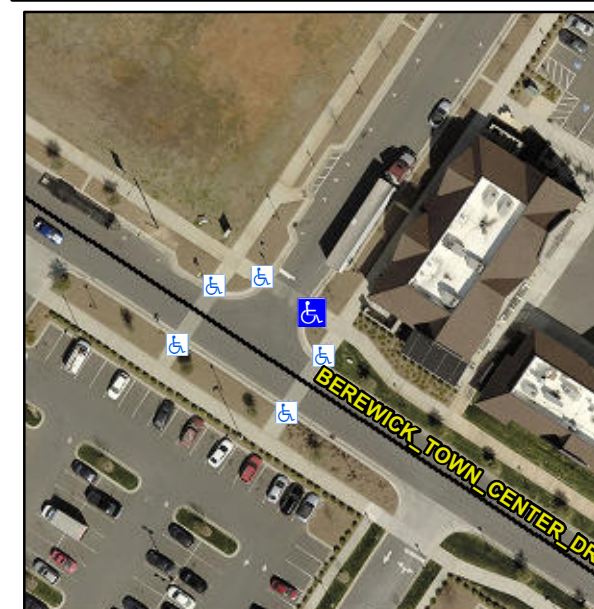
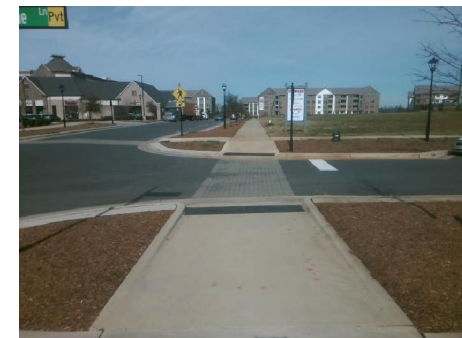
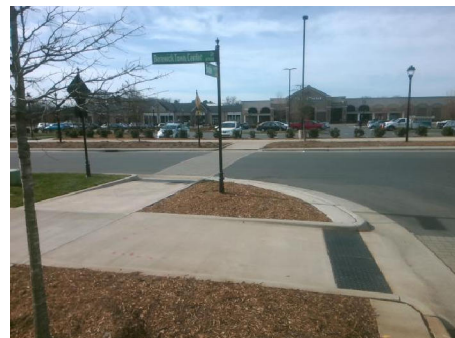
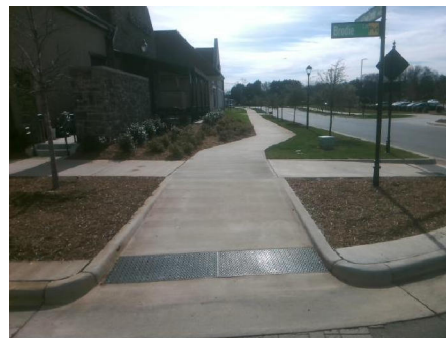
XWALK PAVERS

R304.5.3

Compliance	Description	Data	Compliance	Description	Data
N/A	Ramp Length (in)	180.0	Yes	BlendTrans Slope (%)	3.1
Yes	Ramp Width (in)	94.8	No	BlendTrans XSlope (%)	2.9
N/A	Flare Type LT	N/A	N/A	Flare Type RT	N/A
N/A	Flare Slope LT (%)	N/A	N/A	Flare Slope RT (%)	N/A
N/A	Flare Traversable LT?	N/A	N/A	Flare Traversable RT?	N/A
N/A	Landing Length (in)	N/A	N/A	DWS Provided?	N/A
N/A	Landing Width (in)	N/A	N/A	DWS Contrast?	N/A
N/A	Landing Slope (%)	N/A	N/A	DWS Length (in)	N/A
N/A	Landing X Slope (%)	N/A	N/A	DWS Full Width?	N/A
N/A	Landing Curb? (Y/N)	N/A	N/A	DWS Offset (in)	N/A
N/A	Shared Landing?	N/A			
N/A	Gutter Ponding?	N/A	N/A	Gutter Slope (%)	N/A
N/A	Gutter Lip Ht (in)	N/A	N/A	Gutter X Slope (%)	N/A
N/A	Painted X Walk1?	Yes	N/A	Painted X Walk2?	N/A
	X Walk 1 Direction	To NW		X Walk 2 Direction	N/A
	X Walk 1 Width (in)	97.5		X Walk 2 Width (in)	N/A
	X Walk 1 Slope (%)	0.2		X Walk 2 Slope (%)	N/A
	X Walk 1 X Slope (%)	1.2		X Walk 2 X Slope (%)	N/A

N/A	Ramp inside XWalk1?	Yes	N/A	Ramp inside XWalk2?	N/A
	Road Slope (%)	1.2		Clear Space?	N/A
	Road X Slope (%)	0.2	N/A	Clear Space to XWalk (in)	N/A
N/A	Any Obstructions?	N/A	N/A	Storm Grate/Utility Hazard?	N/A
	Obstruction Type			Storm Grate/Utility Type	
		N/A			N/A
			Yes	Surface Condition? (G/P)	Good
			N/A	Curb Slope (%)	3.2

Remove & Replace Curb Ramp With Two New Directional Ramps or Equivalent.
