Access Compliance Report

Public Rights-of-Way

(Curb Ramps)

Intersection ID: 13767	Main Street: E_5TH_ST	Cross Street: PARK_DR	Location: S
ADA ID: 12A762B10E6C	Ramp Type: PerpDiag	Initial Pass/Fail: Fail	Overall Compliance: No
Severity Score: 25			
Codes/Mitigation Info/Possible Solution		Field Measurements/Component Compliance

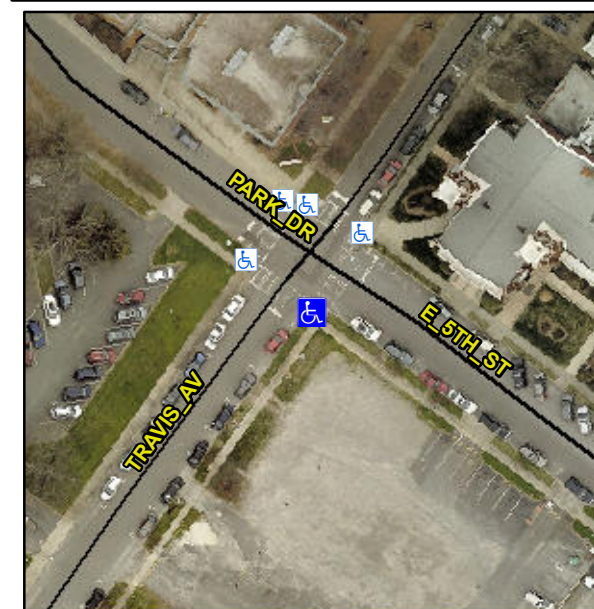
Not Found, R304.2.2

Compliance	Description	Data	Compliance	Description	Data
N/A	Ramp Length (in)	68.0	No	Ramp Slope (%)	17.3
Yes	Ramp Width (in)	116.0	Yes	Ramp XSlope (%)	1.0
N/A	Flare Type LT	N/A	N/A	Flare Type RT	N/A
N/A	Flare Slope LT (%)	N/A	N/A	Flare Slope RT (%)	N/A
N/A	Flare Traversable LT?	N/A	N/A	Flare Traversable RT?	N/A
N/A	Landing Length (in)	N/A	N/A	DWS Provided?	N/A
N/A	Landing Width (in)	N/A	N/A	DWS Contrast?	N/A
N/A	Landing Slope (%)	N/A	N/A	DWS Length (in)	N/A
N/A	Landing X Slope (%)	N/A	N/A	DWS Full Width?	N/A
N/A	Landing Curb? (Y/N)	N/A	N/A	DWS Offset (in)	N/A
N/A	Shared Landing?	N/A			
N/A	Gutter Ponding?	N/A	N/A	Gutter Slope (%)	N/A
N/A	Gutter Lip Ht (in)	2.0	N/A	Gutter X Slope (%)	N/A
N/A	Painted X Walk1?	Yes	N/A	Painted X Walk2?	Yes
	X Walk 1 Direction	To NE		X Walk 2 Direction	To NW
N/A	X Walk 1 Width (in)	112.0	N/A	X Walk 2 Width (in)	112.5
	X Walk 1 Slope (%)	4.5		X Walk 2 Slope (%)	2.8
	X Walk 1 X Slope (%)	1.3		X Walk 2 X Slope (%)	3.3

N/A	Ramp inside XWalk1?	Yes	N/A	Ramp inside XWalk2?	Yes
	Road Slope (%)	1.6	N/A	Clear Space?	N/A
	Road X Slope (%)	5.2	N/A	Clear Space to XWalk (in)	N/A
N/A	Any Obstructions?	N/A	N/A	Storm Grate/Utility Hazard?	N/A
	Obstruction Type			Storm Grate/Utility Type	
		N/A			N/A
		Yes		Surface Condition? (G/P)	Good

Remove & Replace Curb Ramp With Two New Directional Ramps or Equivalent.
