Access Compliance Report

Public Rights-of-Way

(Curb Ramps)

Intersection ID: 13475	Main Street: KENHILL_DR	Cross Street: MARKLAND_DR	Location:	S
ADA ID: 12ABFFDCA2F2	Ramp Type: Directional1	Initial Pass/Fail: Fail	Overall Compliance: No	Severity Score: 10

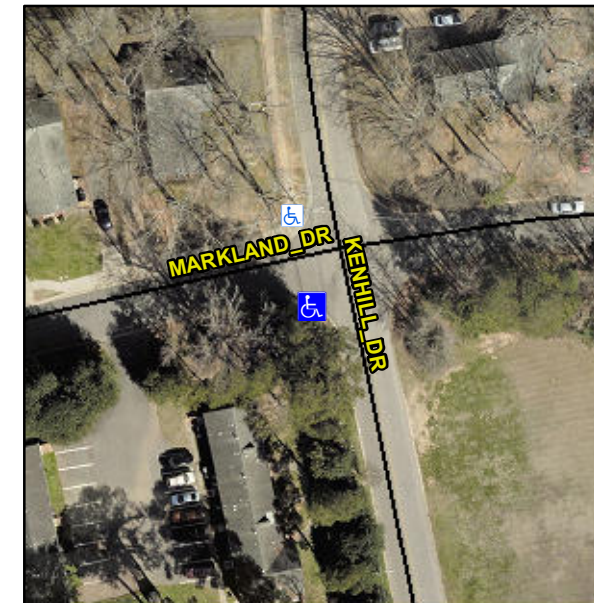
Compliance	Description	Data	Compliance	Description	Data
N/A	Ramp Length (in)	40.0	N/A	Grade Break?	N/A
No	Ramp Width (in)	46.0	N/A	Grade Break Slope (%)	0.0
Yes	Ramp Slope (%)	3.8	N/A	Grade Break XSlope (%)	0.0
No	Ramp XSlope (%)	4.8			
N/A	Flare Type LT	N/A	N/A	Flare Type RT	N/A
N/A	Flare Slope LT (%)	N/A	N/A	Flare Slope RT (%)	0.0
N/A	Flare Traversable LT?	N/A	N/A	Flare Traversable RT?	N/A
N/A	Landing Length (in)	0.0	N/A	DWS Provided?	N/A
N/A	Landing Width (in)	0.0	N/A	DWS Contrast?	N/A
N/A	Landing Slope (%)	0.0	N/A	DWS Length (in)	N/A
N/A	Landing X Slope (%)	0.0	N/A	DWS Full Width?	N/A
N/A	Landing Curb? (Y/N)	N/A	N/A	DWS Offset LT (in)	N/A
N/A	Shared Landing?	N/A	N/A	DWS Offset RT (in)	N/A
N/A	Gutter Ponding?	0.0	N/A	Gutter Slope (%)	N/A
N/A	Gutter Lip Ht (in)	0.0	N/A	Gutter X Slope (%)	N/A
N/A	Painted X Walk1?	No		Road Slope (%)	10.6
	X Walk 1 Direction	To NW		Road X Slope (%)	2.3
	X Walk 1 Width (in)	N/A		Clear Space?	N/A

X Walk 1 Slope (%)	10.6	N/A	Clear Space to XWalk (in)	N/A
	X Walk 1 X Slope (%)	2.3	N/A	Storm Grate/Utility Hazard?	N/A
N/A	Ramp inside XWalk1?	N/A		Storm Grate/Utility Type	
N/A	Any Obstructions?	N/A			N/A
	Obstruction Type		Yes	Surface Condition? (G/P)	Good
			N/A	Curb Slope (%)	6.7

Remove & Replace Entire Ramp.

R304.5.1, R304.5.3

\$ 1600.00
