# Access Compliance Report

## Public Rights-of-Way

| Intersection ID: 24557 | Main Street: PARK_CROSSING_DR | Cross Street: WARWICK_CR | Location: SE |
| ADA ID: 12BE8DFD1EE5 | Ramp Type: PerpDiag | Initial Pass/Fail: Fail | Overall Compliance: No |

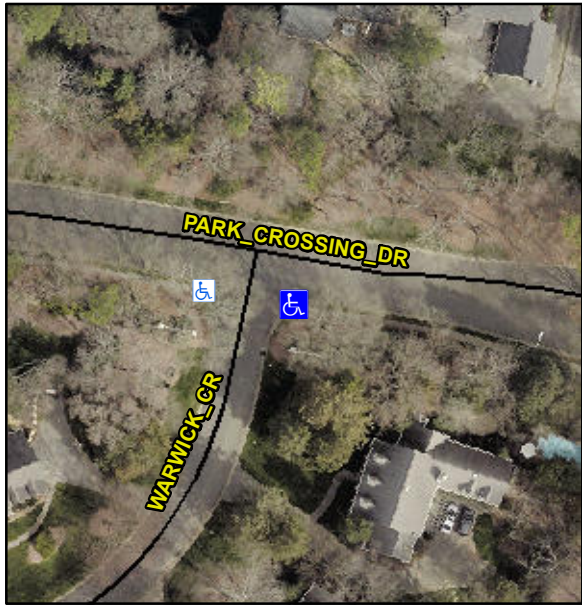
| | | | Severity Score: 13.75 |

| Codes/Mitigation Info/Possible Solution | | | Field Measurements/Component Compliance | | | | | |
|--|--|---|---|---|---|---|---|---|
| | Remove & Replace Curb Ramp With Two New Directional Ramps or Equivalent. | | N/A | Ramp Length (in) | 33.0 | No | Ramp Slope (%) | 8.5 |
| | | | Yes | Ramp Width (in) | 48.0 | No | Ramp XSlope (%) | 2.3 |
| PROW/ADA: | | R304.2.2, R304.5.3 | N/A | Shared Landing? | N/A | | | |

| Codes/Mitigation Info/Possible Solution | | | Field Measurements/Component Compliance | | | | | |
|--|--|---|---|---|---|---|---|---|
| Total Cost: | | \$ 3200.00 | | | | | | |
