# Access Compliance Report

## Public Rights-of-Way

### (Curb Ramps)

Intersection ID: 6171	Main Street: AMHERST_GLEN_DR	Cross Street: ATKINS_RIDGE_DR	Location:	N
ADA ID: 12CC5530D7CF	Ramp Type: Perp	Initial Pass/Fail: Fail	Overall Compliance: No	Severity Score: 21.25

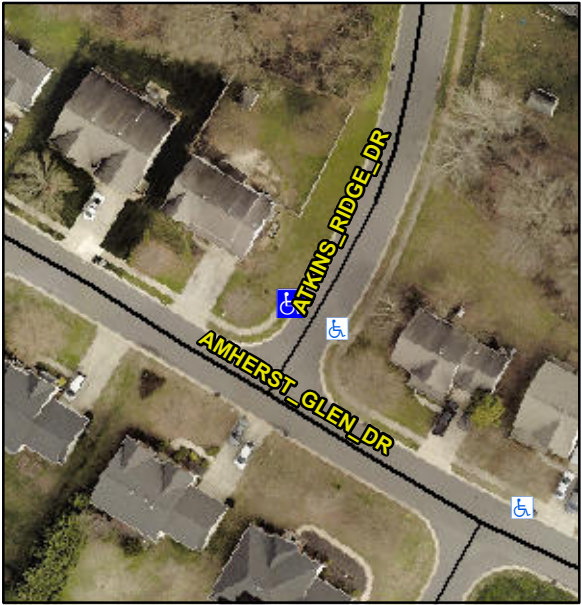
Possible Solutions:		<b>Compliance</b>	<b>Description</b>	<b>Data</b>
	<b>Remove &amp; Replace Entire Ramp.</b>		<b>No</b>	Ramp Length (in)	<b>45.5</b>
			<b>No</b>	Ramp Width (in)	<b>37.5</b>
			<b>N/A</b>	Flare Type LT	<b>N/A</b>
			<b>N/A</b>	Flare Slope LT (%)	<b>N/A</b>
			<b>N/A</b>	Flare Traversable LT?	<b>N/A</b>
			<b>N/A</b>	Landing Length (in)	<b>N/A</b>
			<b>N/A</b>	Landing Width (in)	<b>N/A</b>
			<b>N/A</b>	Landing Slope (%)	<b>N/A</b>
			<b>N/A</b>	Landing X Slope (%)	<b>N/A</b>
<p>Surveyor Notes:</p> <p><b>N/A</b></p> <p>PROW/ADA:</p> <p><b>Not Found, R304.5.1, R304.2.2</b></p>			<b>N/A</b>	Flare Type RT	<b>N/A</b>
			<b>N/A</b>	Flare Slope RT (%)	<b>N/A</b>
			<b>N/A</b>	Flare Traversable RT?	<b>N/A</b>
			<b>N/A</b>	DWS Provided?	<b>N/A</b>
			<b>N/A</b>	DWS Contrast?	<b>N/A</b>
			<b>N/A</b>	DWS Length (in)	<b>N/A</b>

<b>N/A</b>	DWS Full Width?	<b>N/A</b>
			<b>N/A</b>	DWS Offset (in)	<b>N/A</b>
			<b>N/A</b>	Gutter Ponding?	<b>N/A</b>
			<b>N/A</b>	Gutter Lip Ht (in)	<b>N/A</b>
			<b>No</b>	Painted X Walk1?	<b>N/A</b>
				X Walk 1 Direction	<b>To S</b>
			<b>N/A</b>	X Walk 1 Width (in)	<b>N/A</b>
			<b>4.5</b>	X Walk 1 Slope (%)	<b>N/A</b>
			<b>3.0</b>	X Walk 1 X Slope (%)	<b>N/A</b>
			<b>N/A</b>	Ramp inside XWalk1?	<b>N/A</b>
			<b>N/A</b>	Road Slope (%)	<b>N/A</b>
			<b>N/A</b>	Road X Slope (%)	<b>N/A</b>
			<b>N/A</b>	Any Obstructions?	<b>N/A</b>
				Obstruction Type	
Total Cost:					
		<b>\$ 1850.00</b>			
			<b>N/A</b>		<b>N/A</b>
			<b>Yes</b>	Surface Condition? (G/P)	<b>Good</b>
