## **Access Compliance Report Public Rights-of-Way** (Curb Ramps)

Intersection ID: 30677 Main Street: DIXIE HILLS DR **Cross Street: MARVIN RD** Location: NE ADA ID: 12D046E7DB51 Ramp Type: BlendTrans2 Initial Pass/Fail: Fail **Overall Compliance: No Severity Score:** 25

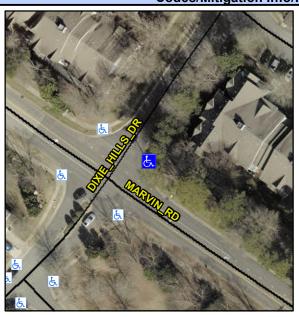
Surveyor Notes: **CURB LIP 2.0**

N/A	Ramp Length (in)	150.0	Yes	BlendTrans Slope (%)	2.5
Yes	Ramp Width (in)	58.0	No	BlendTrans XSlope (%)	7.0
N/A	Flare Type LT	N/A	N/A	Flare Type RT	N/A
N/A	Flare Slope LT (%)	N/A	N/A	Flare Slope RT (%)	N/A
N/A	Flare Traversable LT?	N/A	N/A	Flare Traversable RT?	N/A
N/A	Landing Length (in)	N/A	N/A	DWS Provided?	N/A
N/A	Landing Width (in)	N/A	N/A	DWS Contrast?	N/A
N/A	Landing Slope (%)	N/A	N/A	DWS Length (in)	N/A
N/A	Landing X Slope (%)	N/A	N/A	DWS Full Width?	N/A
N/A	Landing Curb? (Y/N)	N/A	N/A	DWS Offset (in)	N/A
N/A	Shared Landing?	N/A			
N/A	Gutter Ponding?	N/A	N/A	Gutter Slope (%)	N/A
N/A	Gutter Lip Ht (in)	N/A	N/A	Gutter X Slope (%)	N/A
N/A	Painted X Walk1?	No	N/A	Painted X Walk2?	No
	X Walk 1 Direction	To NW		X Walk 2 Direction	To SW
	X Walk 1 Width (in)	N/A		X Walk 2 Width (in)	N/A
	X Walk 1 Slope (%)	4.8		X Walk 2 Slope (%)	1.6
	X Walk 1 X Slope (%)	1.2		X Walk 2 X Slope (%)	5.5
N/A	Ramp inside XWalk1?	N/A	N/A	Ramp inside XWalk2?	N/A

Road Slope (%)	2.9		Clear Space?	N/A
	Road X Slope (%)	4.5	N/A	Clear Space to XWalk (in)	N/A
N/A	Any Obstructions?	N/A	N/A	Storm Grate/Utility Hazard?	N/A
	Obstruction Type		l	Storm Grate/Utility Type	
		N/A	l		N/A
			Yes	Surface Condition? (G/P)	Good
10			N/A	Curb Slope (%)	2.4

Possible Solutions: Remove & Replace Curb Ramp With Two New Directional Ramps or Equivalent.

R304.5.3
