## **Access Compliance Report Public Rights-of-Way** (Curb Ramps)

Intersection ID: 49388 Main Street: SHORTHORN\_ST **Cross Street: DAMASCUS\_ST** Location: NE **Overall Compliance: No** ADA ID: 12E03D498BBA Ramp Type: Perp Initial Pass/Fail: Fail Severity Score: 21.25

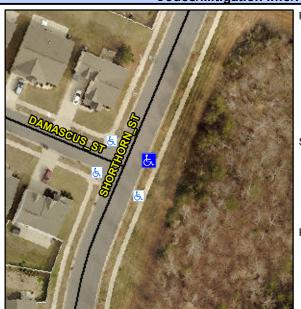
**SHORTHORN ST** Street 1 Name Stop Condition-Street 2 None Street 2 Name N/A Stop Condition-Street 1 N/A

Field Measurements/Component Compliance							
Compl	liance Description	Data	Compl	iance Description	Data		
N/A	Ramp Length (in)	95.0	Yes	Ramp Slope (%)	7.4		
No	Ramp Width (in)	47.0	No	Ramp XSlope (%)	5.2		
N/A	Flare Type LT	N/A	N/A	Flare Type RT	N/A		
N/A	Flare Slope LT (%)	N/A	N/A	Flare Slope RT (%)	N/A		
N/A	Flare Traversable LT?	N/A	N/A	Flare Traversable RT?	N/A		
N/A	Landing Length (in)	N/A	N/A	DWS Provided?	N/A		
N/A	Landing Width (in)	N/A	N/A	DWS Contrast?	N/A		
N/A	Landing Slope (%)	N/A	N/A	DWS Length (in)	N/A		
N/A	Landing X Slope (%)	N/A	N/A	DWS Full Width?	N/A		
N/A	Landing Curb? (Y/N)	N/A	N/A	DWS Offset (in)	N/A		
N/A	Shared Landing?	N/A					
N/A	Gutter Ponding?	N/A	N/A	Gutter Slope (%)	N/A		
N/A	Gutter Lip Ht (in)	N/A	N/A	Gutter X Slope (%)	N/A		
N/A	Painted X Walk1?	No	N/A	Painted X Walk2?	N/A		
	X Walk 1 Direction	To NW		X Walk 2 Direction	N/A		
N/A	X Walk 1 Width (in)	N/A	N/A	X Walk 2 Width (in)	N/A

X Walk 1 Slope (%)	2.9		X Walk 2 Slope (%)	N/A		
	X Walk 1 X Slope (%)	4.5		X Walk 2 X Slope (%)	N/A		
N/A	Ramp inside XWalk1?	N/A	N/A	Ramp inside XWalk2?	N/A		
	Road Slope (%)	N/A	N/A	Clear Space?	N/A		
	Road X Slope (%)	N/A	N/A	Clear Space to XWalk (in)	N/A		
N/A	Any Obstructions?	N/A	N/A	Storm Grate/Utility Hazard?	N/A		
	Obstruction Type			Storm Grate/Utility Type			
		N/A			N/A		
			Yes	Surface Condition? (G/P)	Good

Possible Solutions:	9
Remove & Replace Entire Ramp.	N
	N
	N
	N
	N
	N
Surveyor Notes:	N
N/A	N
	1
	N
	N
PROW/ADA:	N
Not Found, R304.5.1, R304.5.3	N
	N
	N
	N
