# Access Compliance Report

## Public Rights-of-Way

### (Curb Ramps)

| Intersection ID: 9784 | Main Street: FAIRMARKET_PL | Cross Street: THE_PLAZA | Location: | NW |

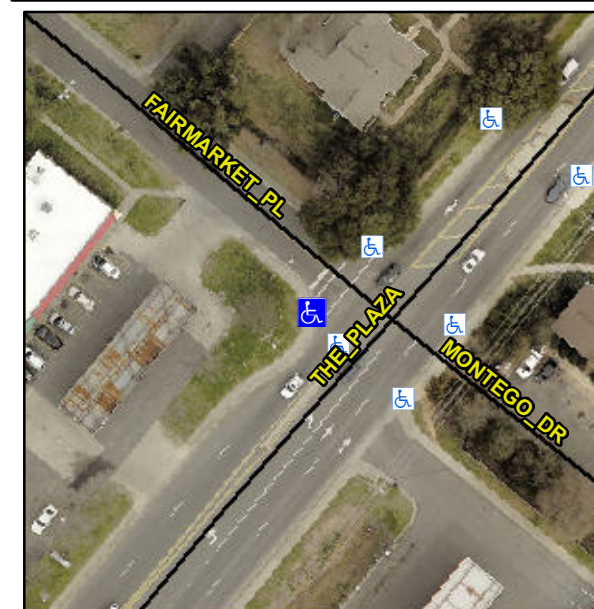
**Not Found, R304.2.1, R304.2.2-Perp, R304.3.2-Para, R304.5.3, R305.2**

| Compliance | Description | Data | Compliance | Description | Data |
|---|---|---|---|---|---|
| No | Landing Length (in) | N/A | Yes | DWS Provided? | Yes |
| No | Landing Width (in) | N/A | Yes | DWS Contrast? | Yes |
| No | Landing Slope (%) | N/A | Yes | DWS Length (in) | 24.0 |
| No | Landing X Slope (%) | N/A | Yes | DWS Full Width? | Yes |
| N/A | Landing Curb? (Y/N) | No | No | DWS Offset (in) | 2.5 |

**Remove & Replace Curb Ramp With Two New Directional Ramps or Equivalent.**

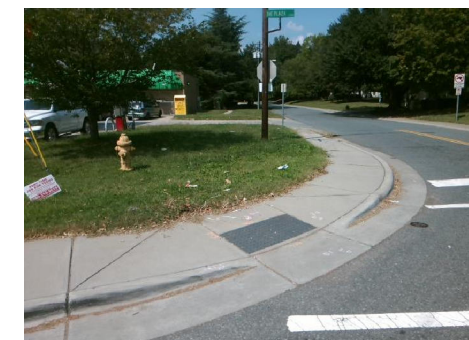
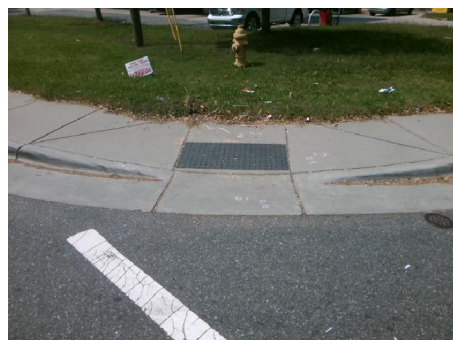
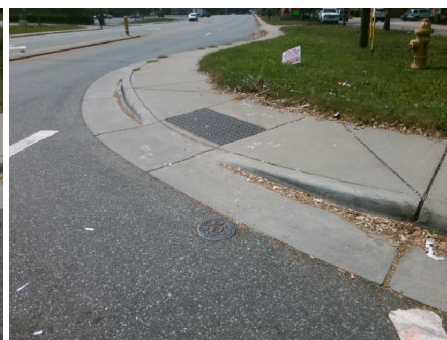
| ADA ID: 12E611BADF24 | Ramp Type: PerpDiag | Initial Pass/Fail: Pass | Overall Compliance: No | Severity Score: 10 |
