# Access Compliance Report

## Public Rights-of-Way

### (Curb Ramps)

| Intersection ID: 7845 | Main Street: KNOLLCREST_DR | Cross Street: RIDGELEY_DR | Location: | N |

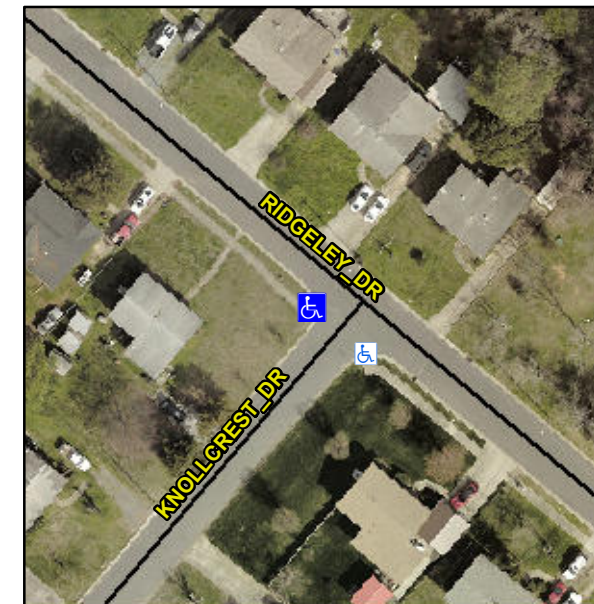
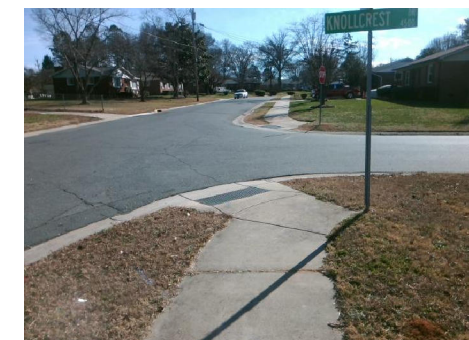
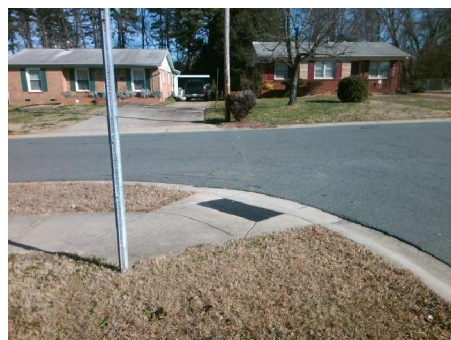
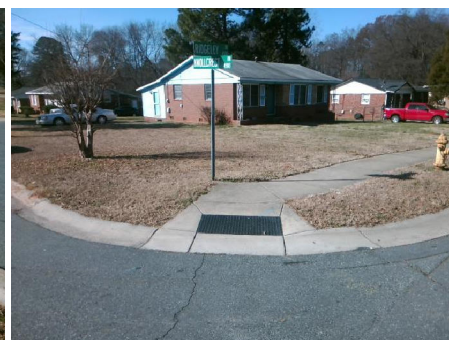
| ADA ID: 12FC13DE0EBC | Ramp Type: Perp | Initial Pass/Fail: Fail | Overall Compliance: No | Severity Score: 13.75 |

| Compliance | Description | Data | Compliance | Description | Data |
|---|---|---|---|---|---|
| N/A | Ramp Length (in) | 45.5 | No | Ramp Slope (%) | 9.0 |
| Yes | Ramp Width (in) | 48.0 | No | Ramp XSlope (%) | 2.4 |

**Remove & Replace Entire Ramp.**

**R304.2.2, R304.5.3**

**\$ 1850.00**
