Access Compliance Report

Public Rights-of-Way

(Curb Ramps)

| Intersection ID: 15011 | Main Street: ALBEMARLE_RD | Cross Street: COPPER_CREEK_CT | Location: SE |

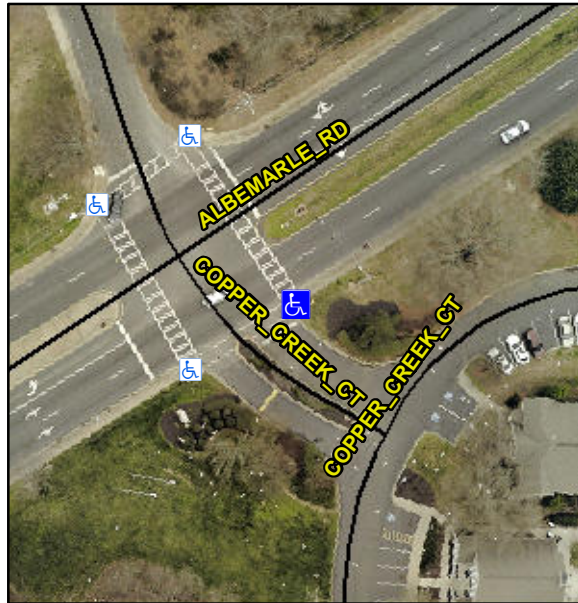
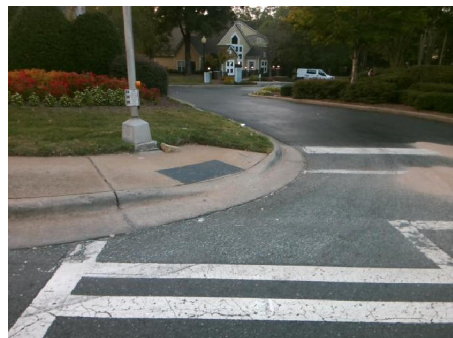
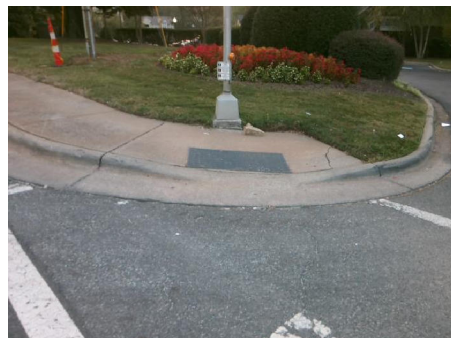
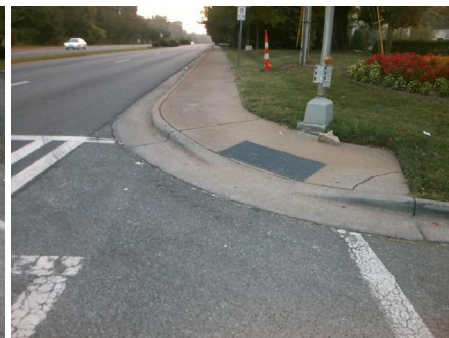
| ADA ID: 131B459E0585 | Ramp Type: PerpDiag | Initial Pass/Fail: Fail | Overall Compliance: No |
| Severity Score: 33.75 | | | |

Not Found, R304.5.1, R304.5.3

| Compliance | Description | Data | Compliance | Description | Data |
|---|---|---|---|---|---|
| N/A | Ramp Length (in) | 60.0 | Yes | Ramp Slope (%) | 7.0 |
| No | Ramp Width (in) | 47.0 | No | Ramp XSlope (%) | 8.0 |

Remove & Replace Curb Ramp With Two New Directional Ramps or Equivalent.
