Access Compliance Report Public Rights-of-Way (Curb Ramps)

Intersection ID: 23437	Main Street: MOSS_RD			Cross Street: S_TRYON_ST					Location:	SE	
ADA ID: 132E10CE512F	32E10CE512F Ramp Type: Perp			Initial I	Pass/Fa	ail: Fail Overall (o Severity Score:	13.75			
Codes/Mitigation Info/Possible Solution					Field Measurements/Component Compliance						
	11 1	Possible Solutions:			Compliance Description			Data Compliance Description		Data	
A A A	1 x 2	Remove & Replace Entire	Ramp		N/A	Ramp Length (in)	95.0	No	Ramp Slope (%)	9.1	
66					Yes	Ramp Width (in)	52.0	No	Ramp XSlope (%)	4.1	
	and the second				N/A	Flare Type LT	N/A	N/A	Flare Type RT	N/A	
E S	min				N/A	Flare Slope LT (%)	N/A	N/A	Flare Slope RT (%)	N/A	
STIP &					N/A	Flare Traversable LT?	N/A	N/A	Flare Traversable RT?	N/A	
6					N/A	Landing Length (in)	N/A	N/A	DWS Provided?	N/A	
	mille	Surveyor Notes:			N/A	Landing Width (in)	N/A	N/A	DWS Contrast?	N/A	
		N/A			N/A	Landing Slope (%)	N/A	N/A	DWS Length (in)	N/A

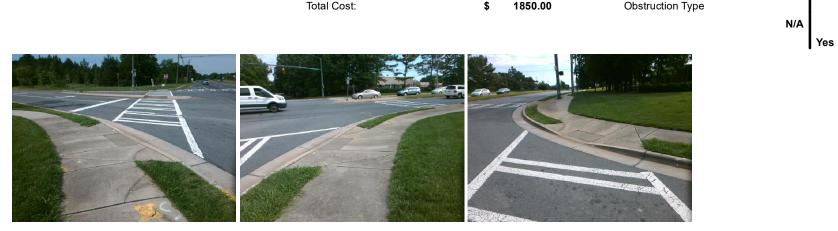
N/A	Landing X Slope (%)	N/A	N/A	DWS Full Width?	N/A	
A A A A	2 × /				N/A	Landing Curb? (Y/N)	N/A	N/A	DWS Offset (in)	N/A	
					N/A	Shared Landing?	N/A				
		PROW/ADA:			N/A	Gutter Ponding?	N/A	N/A	Gutter Slope (%)	N/A	
		Not Found, R304.2.2, R304	4.5.3		N/A	Gutter Lip Ht (in)	N/A	N/A	Gutter X Slope (%)	N/A	
	,,,,,,,,			N/A	Painted X Walk1?	Yes	N/A	Painted X Walk2?	N/A		
					X Walk 1 Direction	To SW		X Walk 2 Direction	N/A		
ACT 2 4				N/A	X Walk 1 Width (in)	116.5	N/A	X Walk 2 Width (in)	N/A		
Street 1 Name	MOSS RD	_				X Walk 1 Slope (%)	0.9		X Walk 2 Slope (%)	N/A	
Stop Condition-Street 2	Signal					X Walk 1 X Slope (%)	2.3		X Walk 2 X Slope (%)	N/A	
Street 2 Name	N/A				N/A	Ramp inside XWalk1?	Yes	N/A	Ramp inside XWalk2?	N/A	
Stop Condition-Street 1	N/A					Road Slope (%)	N/A	N/A	Clear Space?	N/A	
						Road X Slope (%)	N/A	N/A	Clear Space to XWalk (in)	N/A	
					N/A	Any Obstructions?	N/A	N/A	Storm Grate/Utility Hazard?	N/A

Total Cost:	\$	1850.00		Obstruction Type			Storm Grate/Utility Type		
							N/A			N/A
