## **Access Compliance Report Public Rights-of-Way** (Curb Ramps)

Intersection ID: 10147 Main Street: E\_27TH\_ST Cross Street: N\_TRYON\_ST Location: N **Overall Compliance: No** ADA ID: 1332F9A4310C Ramp Type: PerpDiag Initial Pass/Fail: Fail **Severity Score:** 12.5

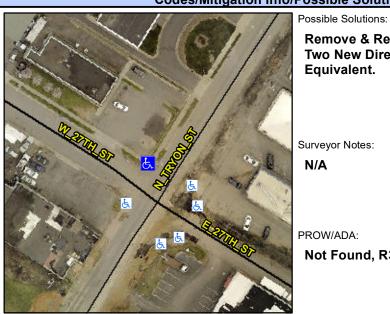
Not Found, R304.5.3

| Comp | liance Description | Data | Comp | liance Description | Data |
|---|---|---|---|---|---|
| Yes | Ramp Width (in) | 71.0 | No | Ramp XSlope (%) | 5.1 |
| N/A | Gutter Ponding? | Yes | N/A | Gutter Slope (%) | N/A |

Street 1 Name Stop Condition-Street 2 Street 2 Name Stop Condition-Street 1 Remove & Replace Curb Ramp With **Two New Directional Ramps or** Equivalent.

Total Cost: 3200.00
