Access Compliance Report

Public Rights-of-Way

(Curb Ramps)

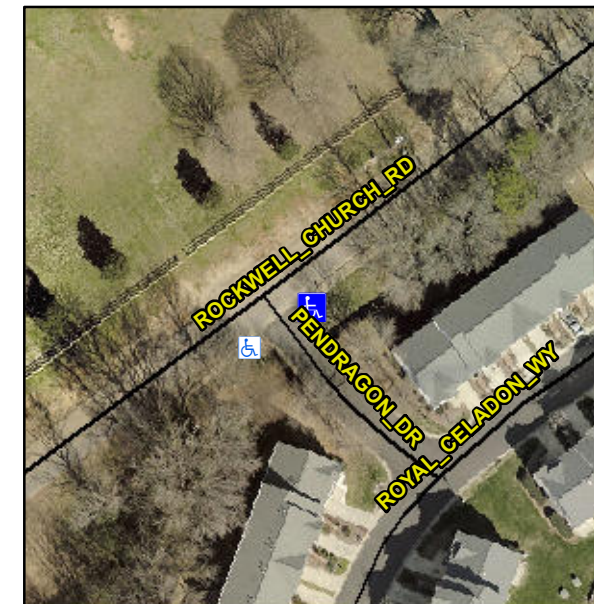
Intersection ID: 31415	Main Street: PENDRAGON_DR	Cross Street: ROCKWELL_CHURCH_RD	Location: E
ADA ID: 1341BE121787	Ramp Type: Perp	Initial Pass/Fail: Fail	Overall Compliance: No
Severity Score: 8.75			
Codes/Mitigation Info/Possible Solution		Field Measurements/Component Compliance

Not Found, R304.5.1

Compliance	Description	Data	Compliance	Description	Data
N/A	Ramp Length (in)	58.0	Yes	Ramp Slope (%)	7.8
No	Ramp Width (in)	44.0	Yes	Ramp XSlope (%)	1.2
N/A	Flare Type LT	N/A	N/A	Flare Type RT	N/A
N/A	Flare Slope LT (%)	N/A	N/A	Flare Slope RT (%)	N/A
N/A	Flare Traversable LT?	N/A	N/A	Flare Traversable RT?	N/A
N/A	Landing Length (in)	N/A	N/A	DWS Provided?	N/A
N/A	Landing Width (in)	N/A	N/A	DWS Contrast?	N/A
N/A	Landing Slope (%)	N/A	N/A	DWS Length (in)	N/A
N/A	Landing X Slope (%)	N/A	N/A	DWS Full Width?	N/A
N/A	Landing Curb? (Y/N)	N/A	N/A	DWS Offset (in)	N/A
N/A	Shared Landing?	N/A			
N/A	Gutter Ponding?	N/A	N/A	Gutter Slope (%)	N/A
N/A	Gutter Lip Ht (in)	N/A	N/A	Gutter X Slope (%)	N/A
N/A	Painted X Walk1?	No	N/A	Painted X Walk2?	N/A
	X Walk 1 Direction	To SW		X Walk 2 Direction	N/A
N/A	X Walk 1 Width (in)	N/A	N/A	X Walk 2 Width (in)	N/A
	X Walk 1 Slope (%)	1.3		X Walk 2 Slope (%)	N/A
	X Walk 1 X Slope (%)	2.0		X Walk 2 X Slope (%)	N/A

N/A	Ramp inside XWalk1?	N/A	N/A	Ramp inside XWalk2?	N/A
	Road Slope (%)	N/A	N/A	Clear Space?	N/A
	Road X Slope (%)	N/A	N/A	Clear Space to XWalk (in)	N/A
N/A	Any Obstructions?	N/A	N/A	Storm Grate/Utility Hazard?	N/A
	Obstruction Type			Storm Grate/Utility Type	
		N/A			N/A
			Yes	Surface Condition? (G/P)	Good

Possible Solutions:

Remove & Replace Entire Ramp.
