Access Compliance Report

Public Rights-of-Way

(Curb Ramps)

Intersection ID: 43093	Main Street: N_POPLAR_ST	Cross Street: W_10TH_ST	Location:	N
ADA ID: 1346390E2F88	Ramp Type: PerpDiag	Initial Pass/Fail: Fail	Overall Compliance: No	Severity Score: 25

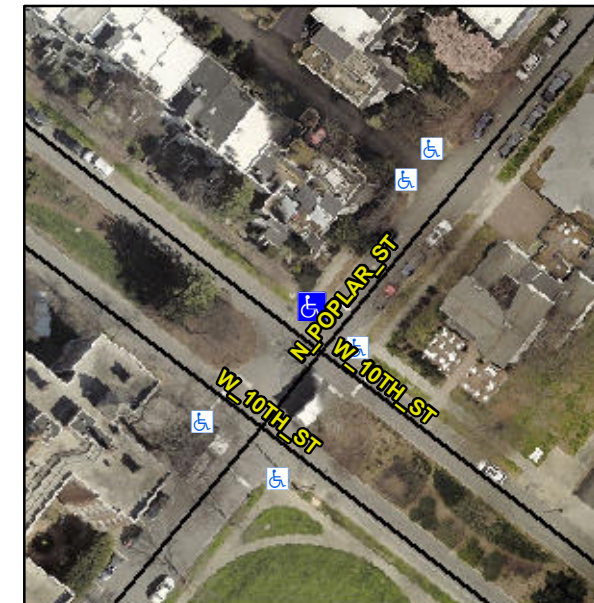
Compliance	Description	Data	Compliance	Description	Data
N/A	Ramp Length (in)	72.0	Yes	Ramp Slope (%)	6.6
Yes	Ramp Width (in)	55.0	No	Ramp XSlope (%)	8.2
N/A	Flare Type LT	N/A	N/A	Flare Type RT	N/A
N/A	Flare Slope LT (%)	N/A	N/A	Flare Slope RT (%)	N/A
N/A	Flare Traversable LT?	N/A	N/A	Flare Traversable RT?	N/A
N/A	Landing Length (in)	N/A	N/A	DWS Provided?	N/A
N/A	Landing Width (in)	N/A	N/A	DWS Contrast?	N/A
N/A	Landing Slope (%)	N/A	N/A	DWS Length (in)	N/A
N/A	Landing X Slope (%)	N/A	N/A	DWS Full Width?	N/A
N/A	Landing Curb? (Y/N)	N/A	N/A	DWS Offset (in)	N/A
N/A	Shared Landing?	N/A			
N/A	Gutter Ponding?	N/A	N/A	Gutter Slope (%)	N/A
N/A	Gutter Lip Ht (in)	N/A	N/A	Gutter X Slope (%)	N/A
N/A	Painted X Walk1?	No	N/A	Painted X Walk2?	No
	X Walk 1 Direction	To SW		X Walk 2 Direction	To SE
N/A	X Walk 1 Width (in)	N/A	N/A	X Walk 2 Width (in)	N/A
	X Walk 1 Slope (%)	9.7		X Walk 2 Slope (%)	6.8
	X Walk 1 X Slope (%)	3.5		X Walk 2 X Slope (%)	5.8

N/A	Ramp inside XWalk1?	N/A	N/A	Ramp inside XWalk2?	N/A
	Road Slope (%)	2.6	N/A	Clear Space?	N/A
	Road X Slope (%)	8.2	N/A	Clear Space to XWalk (in)	N/A
N/A	Any Obstructions?	N/A	N/A	Storm Grate/Utility Hazard?	N/A
	Obstruction Type			Storm Grate/Utility Type	
		N/A			N/A
			Yes	Surface Condition? (G/P)	Good

Possible Solutions:

Remove & Replace Curb Ramp With Two New Directional Ramps or Equivalent.

Not Found, R304.5.3
