# Access Compliance Report

## Public Rights-of-Way

### (Curb Ramps)

Intersection ID: 8896	Main Street: LISA_CAROLE_DR	Cross Street: STONE_BLUFF_CT	Location: NW
ADA ID: 13534454AA9C	Ramp Type: PerpDiag	Initial Pass/Fail: Fail	Overall Compliance: No
		Severity Score: 60

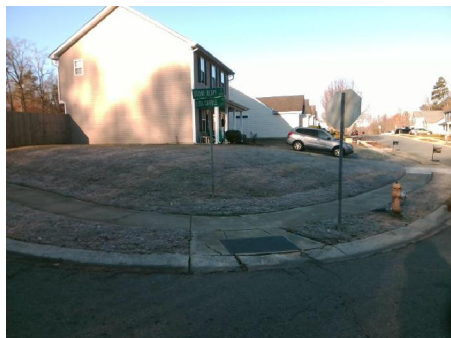
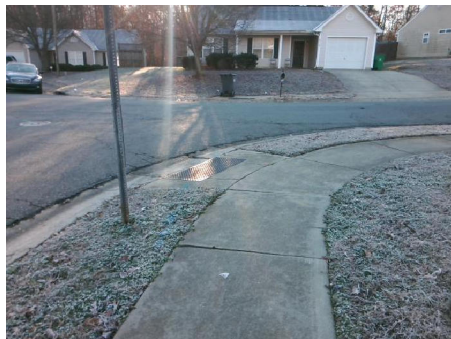
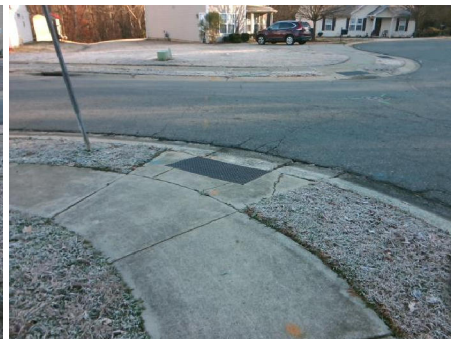
X Walk 1 Slope (%)	<b>3.6</b>		X Walk 2 Slope (%)	<b>2.6</b>
				X Walk 1 X Slope (%)	<b>0.9</b>		X Walk 2 X Slope (%)	<b>1.7</b>
			<b>N/A</b>	Ramp inside XWalk1?	<b>N/A</b>	<b>N/A</b>	Ramp inside XWalk2?	<b>N/A</b>
				Road Slope (%)	<b>2.8</b>	<b>N/A</b>	Clear Space?	<b>N/A</b>
				Road X Slope (%)	<b>3.1</b>	<b>N/A</b>	Clear Space to XWalk (in)	<b>N/A</b>
			<b>N/A</b>	Any Obstructions?	<b>N/A</b>	<b>N/A</b>	Storm Grate/Utility Hazard?	<b>N/A</b>
				Obstruction Type			Storm Grate/Utility Type	
Total Cost:		<b>\$ 3200.00</b>			<b>N/A</b>			<b>N/A</b>
						<b>Yes</b>	Surface Condition? (G/P)	<b>Good</b>

<p>Street 1 Name                      <b>LISA CAROLE DR</b></p> <p>Stop Condition-Street 2                      <b>None</b></p> <p>Street 2 Name                      <b>STONE BLUFF CT</b></p> <p>Stop Condition-Street 1                      <b>StopSign</b></p>	Possible Solutions:		<b>Compliance</b>	<b>Description</b>	<b>Data</b>	<b>Compliance</b>	<b>Description</b>	<b>Data</b>
	<b>Remove &amp; Replace Curb Ramp With Two New Directional Ramps or Equivalent.</b>		<b>N/A</b>	Ramp Length (in)	<b>45.0</b>	<b>No</b>	Ramp Slope (%)	<b>9.2</b>
			<b>No</b>	Ramp Width (in)	<b>29.0</b>	<b>No</b>	Ramp XSlope (%)	<b>5.7</b>
			<b>N/A</b>	Flare Type LT	<b>N/A</b>	<b>N/A</b>	Flare Type RT	<b>N/A</b>
			<b>N/A</b>	Flare Slope LT (%)	<b>N/A</b>	<b>N/A</b>	Flare Slope RT (%)	<b>N/A</b>
			<b>N/A</b>	Flare Traversable LT?	<b>N/A</b>	<b>N/A</b>	Flare Traversable RT?	<b>N/A</b>
