# Access Compliance Report

## Public Rights-of-Way

### (Curb Ramps)

Intersection ID: 32286	Main Street: LANDING_PLACE_LN	Cross Street: SULLIVAN_RIDGE_DR	Location: SE
ADA ID: 1358FEEC1EA6	Ramp Type: PerpDiag	Initial Pass/Fail: Fail	Overall Compliance: No
Severity Score: 21.25			
Codes/Mitigation Info/Possible Solution		Field Measurements/Component Compliance

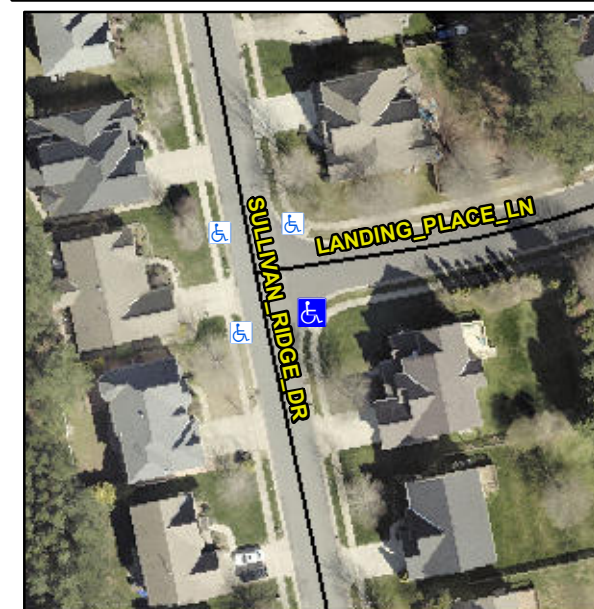
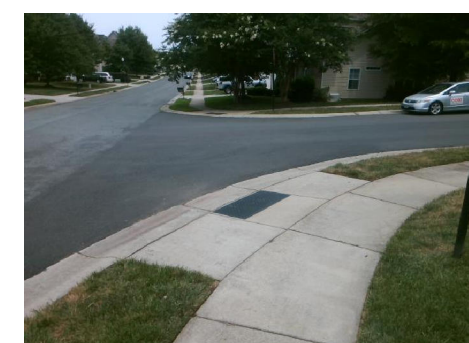
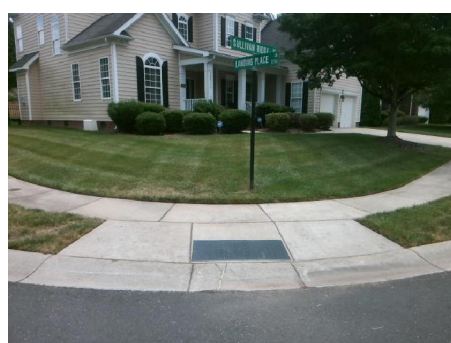
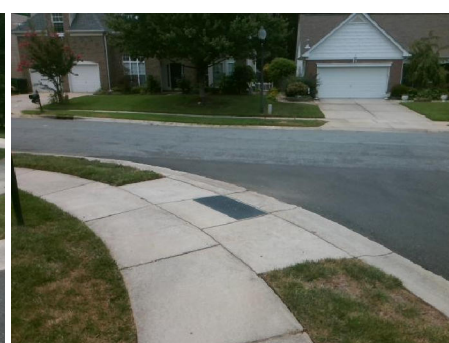
**Not Found, R304.5.1, R304.2.2**

Compliance	Description	Data	Compliance	Description	Data
N/A	Ramp Length (in)	51.0	No	Ramp Slope (%)	10.5
No	Ramp Width (in)	46.0	Yes	Ramp XSlope (%)	1.4
N/A	Flare Type LT	N/A	N/A	Flare Type RT	N/A
N/A	Flare Slope LT (%)	N/A	N/A	Flare Slope RT (%)	N/A
N/A	Flare Traversable LT?	N/A	N/A	Flare Traversable RT?	N/A
N/A	Landing Length (in)	N/A	N/A	DWS Provided?	N/A
N/A	Landing Width (in)	N/A	N/A	DWS Contrast?	N/A
N/A	Landing Slope (%)	N/A	N/A	DWS Length (in)	N/A
N/A	Landing X Slope (%)	N/A	N/A	DWS Full Width?	N/A
N/A	Landing Curb? (Y/N)	N/A	N/A	DWS Offset (in)	N/A
N/A	Shared Landing?	N/A			
N/A	Gutter Ponding?	N/A	N/A	Gutter Slope (%)	N/A
N/A	Gutter Lip Ht (in)	N/A	N/A	Gutter X Slope (%)	N/A
N/A	Painted X Walk1?	No	N/A	Painted X Walk2?	No
	X Walk 1 Direction	To N		X Walk 2 Direction	To W
N/A	X Walk 1 Width (in)	N/A	N/A	X Walk 2 Width (in)	N/A
	X Walk 1 Slope (%)	1.7		X Walk 2 Slope (%)	2.1
	X Walk 1 X Slope (%)	3.3		X Walk 2 X Slope (%)	3.3

N/A	Ramp inside XWalk1?	N/A	N/A	Ramp inside XWalk2?	N/A
	Road Slope (%)	0.9	N/A	Clear Space?	N/A
	Road X Slope (%)	1.3	N/A	Clear Space to XWalk (in)	N/A
N/A	Any Obstructions?	N/A	N/A	Storm Grate/Utility Hazard?	N/A
	Obstruction Type			Storm Grate/Utility Type	
		N/A			N/A
			Yes	Surface Condition? (G/P)	Good

**Remove & Replace Curb Ramp With Two New Directional Ramps or Equivalent.**
