Access Compliance Report

Public Rights-of-Way

(Curb Ramps)

Intersection ID: 10025993	Main Street: ELMHURST_RD	Cross Street: N/A	Location:	N
ADA ID: 1359B0811117	Ramp Type: Combination1	Initial Pass/Fail: Fail	Overall Compliance: No	Severity Score: 13.75
Codes/Mitigation Info/Possible Solution		Field Measurements/Component Compliance

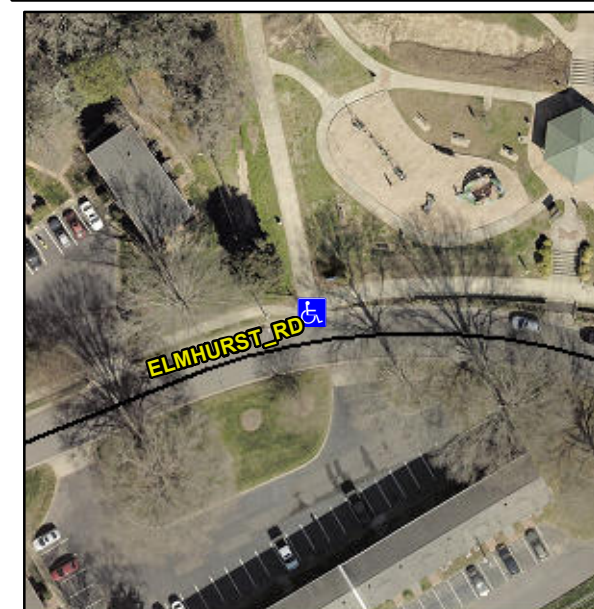
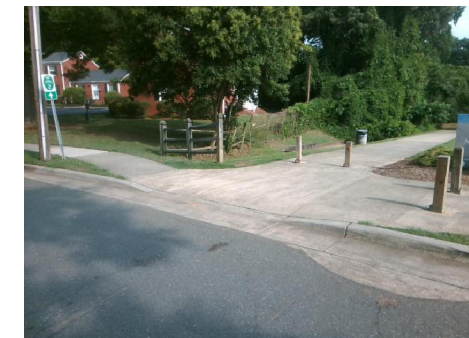
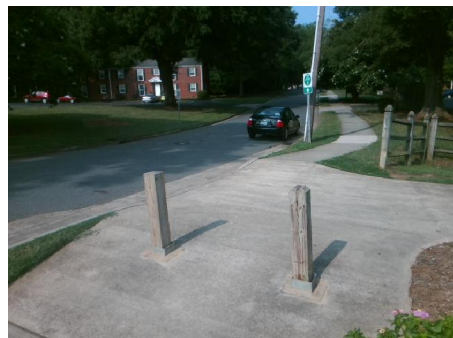
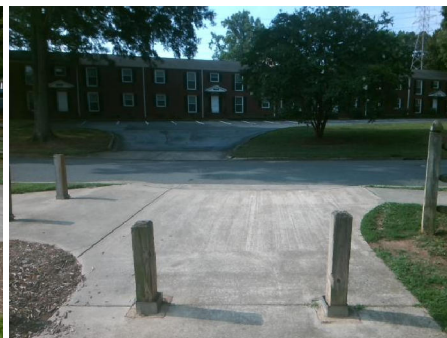
CURB GAP 1.0

Not Found, R304.2.2, R304.3.2, R304.5.3

Compliance	Description	Data	Compliance	Description	Data
N/A	Ramp Length LT (in)	43.0	N/A	Ramp Length RT (in)	38.0
Yes	Ramp Width LT (in)	48.0	Yes	Ramp Width RT (in)	132.0
No	Ramp Slope LT (%)	8.7	Yes	Ramp Slope RT (%)	6.3
No	Ramp XSlope LT (%)	2.9	No	Ramp XSlope RT (%)	3.1
N/A	Ramp Length (in)	12.0	No	Ramp Slope (%)	9.0
Yes	Ramp Width (in)	124.0	Yes	Ramp XSlope (%)	0.4
N/A	Flare Type LT	N/A	N/A	Flare Type RT	N/A
N/A	Flare Slope LT (%)	N/A	N/A	Flare Slope RT (%)	N/A
N/A	Flare Traversable LT?	N/A	N/A	Flare Traversable RT?	N/A
N/A	Landing Length (in)	N/A	N/A	DWS Provided?	N/A
N/A	Landing Width (in)	N/A	N/A	DWS Contrast?	N/A
N/A	Landing Slope (%)	N/A	N/A	DWS Length (in)	N/A
N/A	Landing X Slope (%)	N/A	N/A	DWS Full Width?	N/A
N/A	Landing Curb? (Y/N)	N/A	N/A	DWS Offset (in)	N/A
N/A	Shared Landing?	N/A			
N/A	Gutter Ponding?	N/A	N/A	Gutter Slope (%)	N/A
N/A	Gutter Lip Ht (in)	N/A	N/A	Gutter X Slope (%)	N/A
N/A	Painted X Walk1?	No	N/A	Painted X Walk2?	N/A

X Walk 1 Direction	To S		X Walk 2 Direction	N/A
	X Walk 1 Width (in)	N/A		X Walk 2 Width (in)	N/A
	X Walk 1 Slope (%)	3.1		X Walk 2 Slope (%)	N/A
	X Walk 1 X Slope (%)	0.4		X Walk 2 X Slope (%)	N/A
N/A	Ramp inside XWalk1?	N/A	N/A	Ramp inside XWalk2?	N/A
	Road Slope (%)	N/A		Clear Space?	N/A
	Road X Slope (%)	N/A	N/A	Clear Space to XWalk (in)	N/A
			N/A	Any Obstruction?	N/A
				Obstruction Type	N/A
			N/A	Storm Grate/Utility Hazard?	N/A
				Storm Grate/Utility Type	N/A
					N/A
Yes	Surface Condition? (G/P)	Good			
	Curb Slope (%)	17.7

Remove & Replace Entire Ramp.

Total Cost: \$ 1800.00
