Access Compliance Report

Public Rights-of-Way

(Curb Ramps)

Intersection ID: 16310	Main Street: LYNNVILLE_AV	Cross Street: N_SHARON_AMITY_RD	Location: N
ADA ID: 1364B8D90826	Ramp Type: PerpDiag	Initial Pass/Fail: Fail	Overall Compliance: No
Severity Score: 21.25			
Codes/Mitigation Info/Possible Solution		Field Measurements/Component Compliance

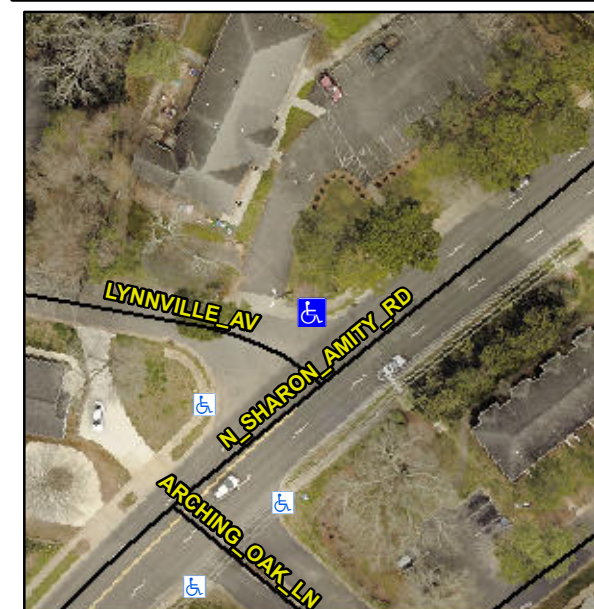
Not Found, R304.5.1, R304.5.3

Compliance	Description	Data	Compliance	Description	Data
N/A	Ramp Length (in)	84.0	Yes	Ramp Slope (%)	5.3
No	Ramp Width (in)	41.0	No	Ramp XSlope (%)	5.2
N/A	Flare Type LT	N/A	N/A	Flare Type RT	N/A
N/A	Flare Slope LT (%)	N/A	N/A	Flare Slope RT (%)	N/A
N/A	Flare Traversable LT?	N/A	N/A	Flare Traversable RT?	N/A
N/A	Landing Length (in)	N/A	N/A	DWS Provided?	N/A
N/A	Landing Width (in)	N/A	N/A	DWS Contrast?	N/A
N/A	Landing Slope (%)	N/A	N/A	DWS Length (in)	N/A
N/A	Landing X Slope (%)	N/A	N/A	DWS Full Width?	N/A
N/A	Landing Curb? (Y/N)	N/A	N/A	DWS Offset (in)	N/A
N/A	Shared Landing?	N/A			
N/A	Gutter Ponding?	Yes	N/A	Gutter Slope (%)	N/A
N/A	Gutter Lip Ht (in)	N/A	N/A	Gutter X Slope (%)	N/A
N/A	Painted X Walk1?	No	N/A	Painted X Walk2?	No
	X Walk 1 Direction	To SW		X Walk 2 Direction	To S
N/A	X Walk 1 Width (in)	N/A	N/A	X Walk 2 Width (in)	N/A
	X Walk 1 Slope (%)	2.2		X Walk 2 Slope (%)	1.2
	X Walk 1 X Slope (%)	1.3		X Walk 2 X Slope (%)	1.7

N/A	Ramp inside XWalk1?	N/A	N/A	Ramp inside XWalk2?	N/A
	Road Slope (%)	1.0	N/A	Clear Space?	N/A
	Road X Slope (%)	1.3	N/A	Clear Space to XWalk (in)	N/A
N/A	Any Obstructions?	N/A	N/A	Storm Grate/Utility Hazard?	N/A
	Obstruction Type			Storm Grate/Utility Type	
		N/A			N/A
		Yes		Surface Condition? (G/P)	Good

Possible Solutions:

Remove & Replace Curb Ramp With Two New Directional Ramps or Equivalent.
