Access Compliance Report Public Rights-of-Way (Curb Ramps)

Intersection ID: 11835 Main Street: BELMONT AV Cross Street: N DAVIDSON ST Location: Ε **Overall Compliance: No Severity Score:** 10 ADA ID: 13683DB4244E Ramp Type: BlendTrans2 Initial Pass/Fail: Fail

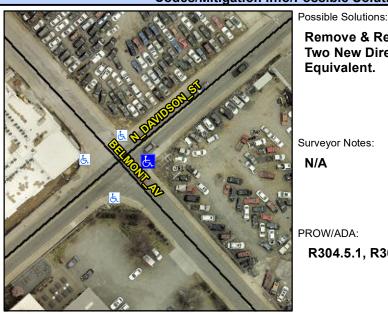
Compliance Description Data Compliance Description Data Yes N/A Ramp Length (in) 47.0 BlendTrans Slope (%) 1.6 38.0 No No Ramp Width (in) BlendTrans XSlope (%) 3.0 N/A N/A Flare Type LT N/A Flare Type RT N/A N/A Flare Slope LT (%) N/A N/A Flare Slope RT (%) N/A N/A Flare Traversable LT? N/A N/A Flare Traversable RT? N/A N/A Landing Length (in) N/A N/A **DWS Provided?** N/A N/A Landing Width (in) N/A N/A **DWS Contrast?** N/A N/A N/A N/A Landing Slope (%) DWS Length (in) N/A N/A Landing X Slope (%) N/A N/A DWS Full Width? N/A N/A Landing Curb? (Y/N) N/A N/A DWS Offset (in) N/A N/A N/A Shared Landing? N/A **Gutter Ponding?** N/A N/A Gutter Slope (%) N/A N/A Gutter Lip Ht (in) N/A N/A Gutter X Slope (%) N/A N/A Painted X Walk1? No N/A Painted X Walk2? No X Walk 1 Direction To NW X Walk 2 Direction To SW N/A X Walk 1 Width (in) X Walk 2 Width (in) N/A X Walk 1 Slope (%) X Walk 2 Slope (%) 2.5 3.1 X Walk 1 X Slope (%) 2.7 X Walk 2 X Slope (%) 1.4 N/A N/A Ramp inside XWalk2? N/A N/A Ramp inside XWalk1? Road Slope (%) 0.9 Clear Space? N/A Road X Slope (%) 2.3 N/A Clear Space to XWalk (in) N/A N/A N/A N/A Any Obstructions? Storm Grate/Utility Hazard? N/A **Obstruction Type** Storm Grate/Utility Type N/A N/A Yes Surface Condition? (G/P) Good N/A Curb Slope (%) 3.9

Remove & Replace Curb Ramp With Two New Directional Ramps or Equivalent.

R304.5.1, R304.5.3
