## **Access Compliance Report Public Rights-of-Way** (Curb Ramps)

Intersection ID: 8437 Main Street: OLD CONCORD RD Cross Street: ORR\_RD Location: SE **Overall Compliance: No ADA ID: 136CE857EE9C** Ramp Type: Perp Initial Pass/Fail: Fail **Severity Score:** 12.5

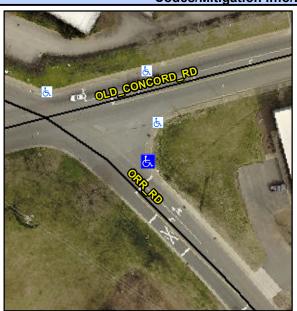
Field Measurements/Component Compliance							
	Comp	liance Description	Data	Comp	liance Description	Data		
	N/A	Ramp Length (in)	60.0	No	Ramp Slope (%)	9.0		
	Yes	Ramp Width (in)	48.0	Yes	Ramp XSlope (%)	0.2		
	N/A	Flare Type LT	N/A	N/A	Flare Type RT	N/A		
	N/A	Flare Slope LT (%)	N/A	N/A	Flare Slope RT (%)	N/A		
	N/A	Flare Traversable LT?	N/A	N/A	Flare Traversable RT?	N/A		
	N/A	Landing Length (in)	N/A	N/A	DWS Provided?	N/A		
	N/A	Landing Width (in)	N/A	N/A	DWS Contrast?	N/A		
	N/A	Landing Slope (%)	N/A	N/A	DWS Length (in)	N/A		
	N/A	Landing X Slope (%)	N/A	N/A	DWS Full Width?	N/A		
	N/A	Landing Curb? (Y/N)	N/A	N/A	DWS Offset (in)	N/A		
	N/A	Shared Landing?	N/A					
	N/A	Gutter Ponding?	N/A	N/A	Gutter Slope (%)	N/A		
	N/A	Gutter Lip Ht (in)	N/A	N/A	Gutter X Slope (%)	N/A		
	N/A	Painted X Walk1?	No	N/A	Painted X Walk2?	N/A		
		X Walk 1 Direction	To W		X Walk 2 Direction	N/A		
	N/A	X Walk 1 Width (in)	N/A	N/A	X Walk 2 Width (in)	N/A

X Walk 1 Slope (%)	5.7		X Walk 2 Slope (%)	N/A		
		X Walk 1 X Slope (%)	0.1		X Walk 2 X Slope (%)	N/A		
	N/A	Ramp inside XWalk1?	N/A	N/A	Ramp inside XWalk2?	N/A		
		Road Slope (%)	0.1	N/A	Clear Space?	N/A		
		Road X Slope (%)	5.7	N/A	Clear Space to XWalk (in)	N/A		
	N/A	Any Obstructions?	N/A	N/A	Storm Grate/Utility Hazard?	N/A		
		Obstruction Type			Storm Grate/Utility Type			
			N/A			N/A		
				Yes	Surface Condition? (G/P)	Good		
П	- = =

Possible Solutions:	C			
Remove & Replace Entire Ramp.				
	Υe			
	N/			
Surveyor Notes:	N/			
N/A	N/			
	N/			
	N/			
	N/			
PROW/ADA:	N/			
Not Found, R304.2.2	N/
