# Access Compliance Report

## Public Rights-of-Way

### (Curb Ramps)

Intersection ID: 43242	Main Street: I-485_RA	Cross Street: S_I-77_HY	Location:	N
ADA ID: 137764194E27	Ramp Type: Perp	Initial Pass/Fail: Fail	Overall Compliance: No	Severity Score: 8.75
Codes/Mitigation Info/Possible Solution		Field Measurements/Component Compliance

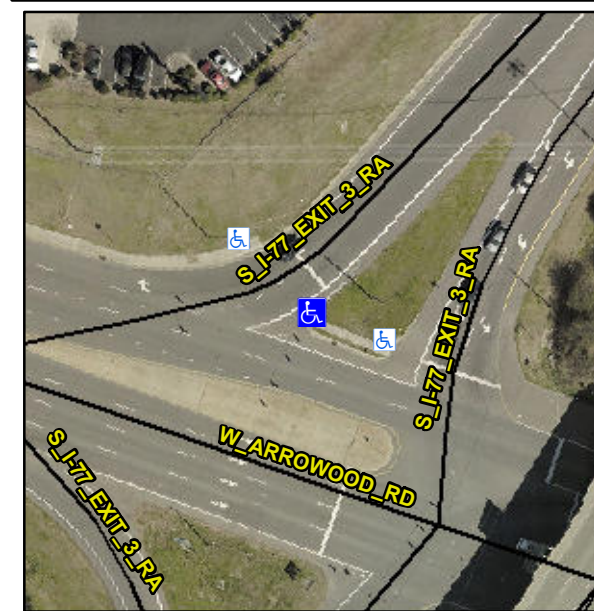
**Not Found, R304.5.1**

Compliance	Description	Data	Compliance	Description	Data
N/A	Ramp Length (in)	46.0	Yes	Ramp Slope (%)	6.1
No	Ramp Width (in)	45.0	Yes	Ramp XSlope (%)	0.4
N/A	Flare Type LT	N/A	N/A	Flare Type RT	N/A
N/A	Flare Slope LT (%)	N/A	N/A	Flare Slope RT (%)	N/A
N/A	Flare Traversable LT?	N/A	N/A	Flare Traversable RT?	N/A
N/A	Landing Length (in)	N/A	N/A	DWS Provided?	N/A
N/A	Landing Width (in)	N/A	N/A	DWS Contrast?	N/A
N/A	Landing Slope (%)	N/A	N/A	DWS Length (in)	N/A
N/A	Landing X Slope (%)	N/A	N/A	DWS Full Width?	N/A
N/A	Landing Curb? (Y/N)	N/A	N/A	DWS Offset (in)	N/A
N/A	Shared Landing?	N/A			
N/A	Gutter Ponding?	N/A	N/A	Gutter Slope (%)	N/A
N/A	Gutter Lip Ht (in)	N/A	N/A	Gutter X Slope (%)	N/A
N/A	Painted X Walk1?	No	N/A	Painted X Walk2?	N/A
	X Walk 1 Direction	To N		X Walk 2 Direction	N/A
N/A	X Walk 1 Width (in)	N/A	N/A	X Walk 2 Width (in)	N/A
	X Walk 1 Slope (%)	0.9		X Walk 2 Slope (%)	N/A
	X Walk 1 X Slope (%)	0.6		X Walk 2 X Slope (%)	N/A

**Remove & Replace Entire Ramp.**
