# Access Compliance Report

## Public Rights-of-Way

### (Curb Ramps)

| Intersection ID: 16483 | Main Street: QUEENS_RD | Cross Street: RADCLIFFE_AV | Location: SE |

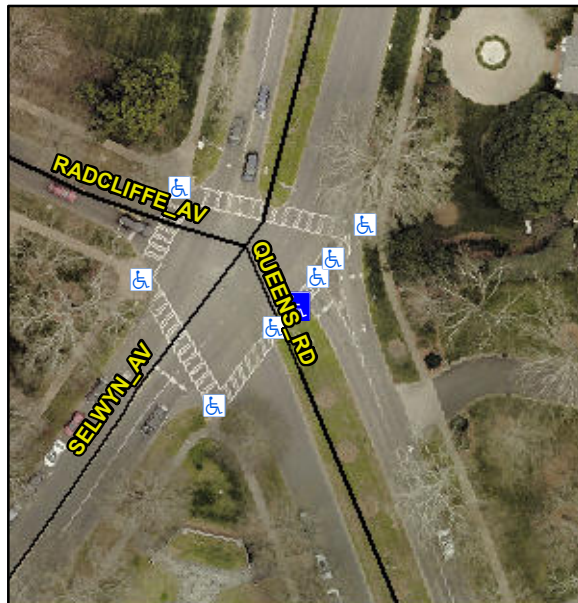
**Not Found, R304.5.1, R304.5.3**

| Compliance | Description | Data | Compliance | Description | Data |
|---|---|---|---|---|---|
| N/A | Ramp Length (in) | 79.0 | Yes | Ramp Slope (%) | 6.1 |
| No | Ramp Width (in) | 45.0 | No | Ramp XSlope (%) | 2.6 |

**Remove & Replace Entire Ramp.**

Total Cost: \$ 1650.00
