Access Compliance Report

Public Rights-of-Way

(Curb Ramps)

| Intersection ID: 5365 | Main Street: MT_HOLLY-HUNTERSVILLE_RD | Cross Street: NEWFOUND_HOLLOW_DR | Location: NW |

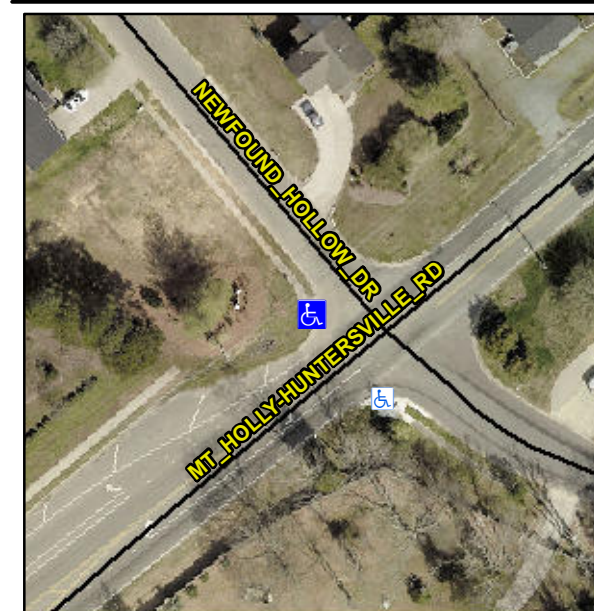
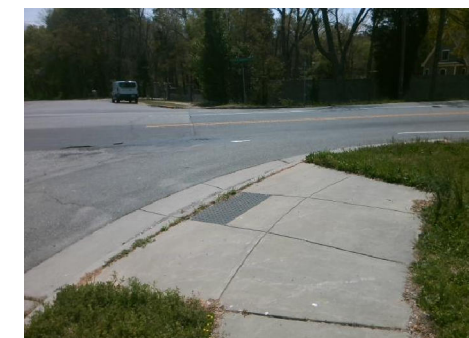
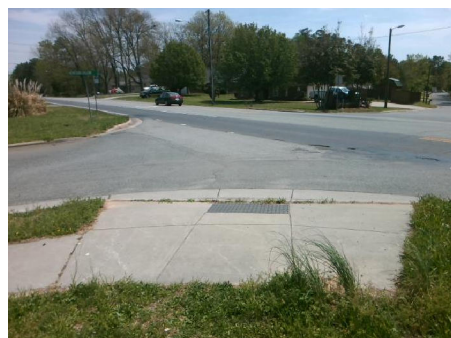
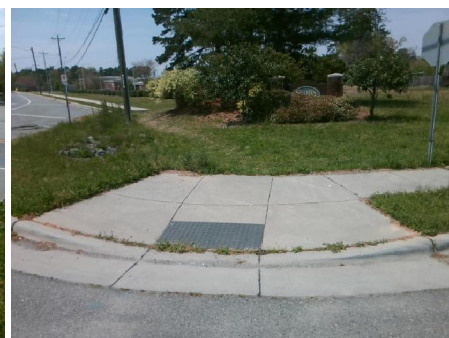
Not Found, R304.2.2

| Compliance | Description | Data | Compliance | Description | Data |
|---|---|---|---|---|---|
| N/A | Ramp Length (in) | 48.0 | No | Ramp Slope (%) | 8.4 |

Remove & Replace Entire Ramp.
