Access Compliance Report

Public Rights-of-Way

(Curb Ramps)

Intersection ID: 9256	Main Street: BOONE_ST	Cross Street: RENNER_ST	Location: SW
ADA ID: 139C1D19C020	Ramp Type: Perp	Initial Pass/Fail: Fail	Overall Compliance: No
		Severity Score: 12.5

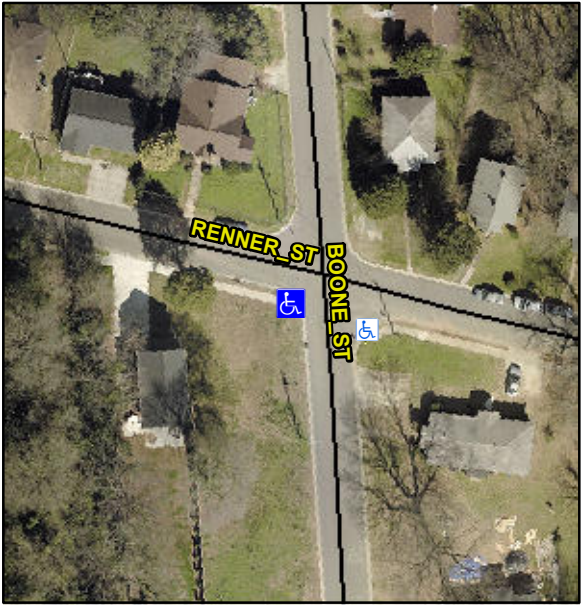
Possible Solutions:		Compliance	Description	Data
	Remove & Replace Entire Ramp.		No	Ramp Length (in)	27.0
			Yes	Ramp Width (in)	48.0
			N/A	Flare Type LT	N/A
			N/A	Flare Slope LT (%)	N/A
			N/A	Flare Traversable LT?	N/A
			N/A	Landing Length (in)	N/A
			N/A	Landing Width (in)	N/A
			N/A	Landing Slope (%)	N/A
			N/A	Landing X Slope (%)	N/A
<p>Surveyor Notes:</p> <p>N/A</p> <p>PROW/ADA:</p> <p>Not Found, R304.2.2</p>			N/A	Flare Type RT	N/A
			N/A	Flare Slope RT (%)	N/A
			N/A	Flare Traversable RT?	N/A
			N/A	DWS Provided?	N/A
			N/A	DWS Contrast?	N/A
			N/A	DWS Length (in)	N/A
			N/A	DWS Full Width?	N/A
			N/A	DWS Offset (in)	N/A
			N/A	Gutter Ponding?	N/A
			N/A	Gutter Lip Ht (in)	N/A
			No	Painted X Walk1?	N/A
				X Walk 1 Direction	To SE
			N/A	X Walk 1 Width (in)	N/A
				X Walk 1 Slope (%)	1.0
				X Walk 1 X Slope (%)	1.5

N/A	Ramp inside XWalk1?	N/A
			N/A	Road Slope (%)	N/A
			N/A	Road X Slope (%)	N/A
			N/A	Any Obstructions?	N/A
				Obstruction Type	
Total Cost:					
		\$ 1850.00			
			N/A	Clear Space?	N/A
			N/A	Clear Space to XWalk (in)	N/A
			N/A	Storm Grate/Utility Hazard?	N/A
				Storm Grate/Utility Type	
			N/A		N/A
			Yes	Surface Condition? (G/P)	Good
