# Access Compliance Report

## Public Rights-of-Way

### (Curb Ramps)

Intersection ID: 11422	Main Street: N_MCDOWELL_ST	Cross Street: PARKWOOD_AV	Location: NE
ADA ID: 13A0DDF5B782	Ramp Type: Perp	Initial Pass/Fail: Fail	Overall Compliance: No
Severity Score: 46.25			
Codes/Mitigation Info/Possible Solution		Field Measurements/Component Compliance

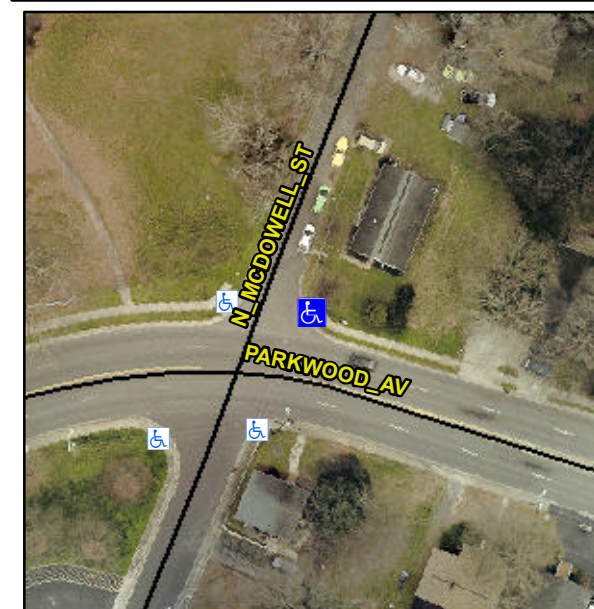
**Not Found, R304.5.1, R304.2.2, R304.5.3**

Compliance	Description	Data	Compliance	Description	Data
N/A	Ramp Length (in)	86.5	No	Ramp Slope (%)	8.8
No	Ramp Width (in)	44.5	No	Ramp XSlope (%)	11.4
N/A	Flare Type LT	N/A	N/A	Flare Type RT	N/A
N/A	Flare Slope LT (%)	N/A	N/A	Flare Slope RT (%)	N/A
N/A	Flare Traversable LT?	N/A	N/A	Flare Traversable RT?	N/A
N/A	Landing Length (in)	N/A	N/A	DWS Provided?	N/A
N/A	Landing Width (in)	N/A	N/A	DWS Contrast?	N/A
N/A	Landing Slope (%)	N/A	N/A	DWS Length (in)	N/A
N/A	Landing X Slope (%)	N/A	N/A	DWS Full Width?	N/A
N/A	Landing Curb? (Y/N)	N/A	N/A	DWS Offset (in)	N/A
N/A	Shared Landing?	N/A			
N/A	Gutter Ponding?	N/A	N/A	Gutter Slope (%)	N/A
N/A	Gutter Lip Ht (in)	N/A	N/A	Gutter X Slope (%)	N/A
N/A	Painted X Walk1?	No	N/A	Painted X Walk2?	N/A
	X Walk 1 Direction	To W		X Walk 2 Direction	N/A
N/A	X Walk 1 Width (in)	N/A	N/A	X Walk 2 Width (in)	N/A
	X Walk 1 Slope (%)	5.0		X Walk 2 Slope (%)	N/A
	X Walk 1 X Slope (%)	8.7		X Walk 2 X Slope (%)	N/A

**Remove & Replace Entire Ramp.**

Total Cost: \$ 1850.00

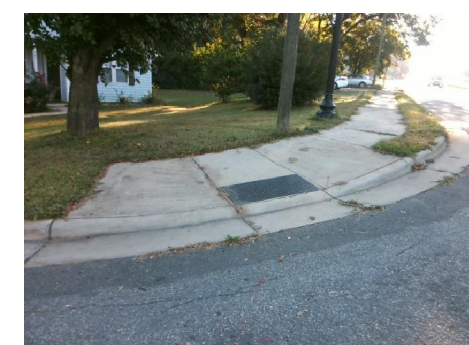
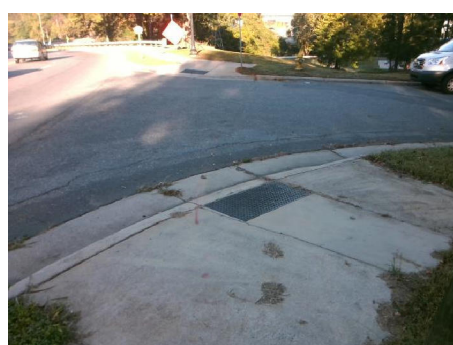
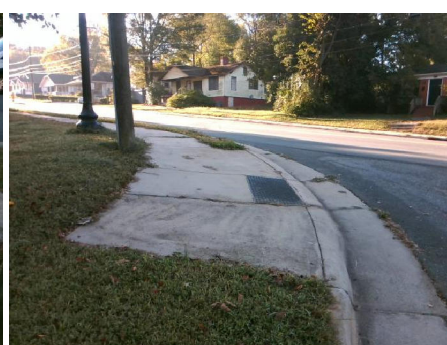
N/A	Ramp inside XWalk1?	N/A	N/A	Ramp inside XWalk2?	N/A
	Road Slope (%)	N/A	N/A	Clear Space?	N/A
	Road X Slope (%)	N/A	N/A	Clear Space to XWalk (in)	N/A
N/A	Any Obstructions?	N/A	N/A	Storm Grate/Utility Hazard?	N/A
	Obstruction Type			Storm Grate/Utility Type	
		N/A			N/A
			Yes	Surface Condition? (G/P)	Good
