Access Compliance Report Public Rights-of-Way (Curb Ramps)

Intersection ID: N/A Main Street: STYLE_LN Cross Street: OUTLETS_BV Location: SE

ADA ID: 13A6831AA630 Ramp Type: PerpDiag Initial Pass/Fail: Fail Overall Compliance: No Severity Score: 13.75

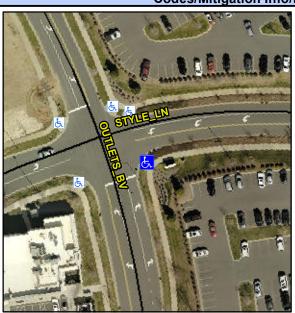
Not Found, R304.2.2, R304.5.3

Field Measurer	<u>nents/C</u>	ompo	nent Compliance	
Comp	liance Description	Data	Comp	liance Description	Data
N/A	Ramp Length (in)	98.0	No	Ramp Slope (%)	9.1
Yes	Ramp Width (in)	48.0	No	Ramp XSlope (%)	4.1
N/A	Flare Type LT	N/A	N/A	Flare Type RT	N/A
N/A	Flare Slope LT (%)	N/A	N/A	Flare Slope RT (%)	N/A
N/A	Flare Traversable LT?	N/A	N/A	Flare Traversable RT?	N/A
N/A	Landing Length (in)	N/A	N/A	DWS Provided?	N/A
N/A	Landing Width (in)	N/A	N/A	DWS Contrast?	N/A
N/A	Landing Slope (%)	N/A	N/A	DWS Length (in)	N/A
N/A	Landing X Slope (%)	N/A	N/A	DWS Full Width?	N/A
N/A	Landing Curb? (Y/N)	N/A	N/A	DWS Offset (in)	N/A
N/A	Shared Landing?	N/A			
N/A	Gutter Ponding?	N/A	N/A	Gutter Slope (%)	N/A
N/A	Gutter Lip Ht (in)	N/A	N/A	Gutter X Slope (%)	N/A
N/A	Painted X Walk1?	No	N/A	Painted X Walk2?	No
	X Walk 1 Direction	To N		X Walk 2 Direction	To W
N/A	X Walk 1 Width (in)	N/A	N/A	X Walk 2 Width (in)	N/A
	X Walk 1 Slope (%)	1.6		X Walk 2 Slope (%)	2.5

X Walk 1 X Slope (%)	0.9		X Walk 2 X Slope (%)	4.1
N/A	Ramp inside XWalk1?	N/A	N/A	Ramp inside XWalk2?	N/A
	Road Slope (%)	0.7	N/A	Clear Space?	N/A
	Road X Slope (%)	1.4	N/A	Clear Space to XWalk (in)	N/A
N/A	Any Obstructions?	N/A	N/A	Storm Grate/Utility Hazard?	N/A
	Obstruction Type			Storm Grate/Utility Type	
	••	N/A		,	N/A
			Yes	Surface Condition? (G/P)	Good
, Car	Mark to the last t	'	-	. ,

Remove & Replace Curb Ramp With Two New Directional Ramps or Equivalent.
